Management of an advanced peri-implantitis

Clinical case (Case presentation & Movie)

Dr. Young-Ku Heo, DDS, MDS, PhD

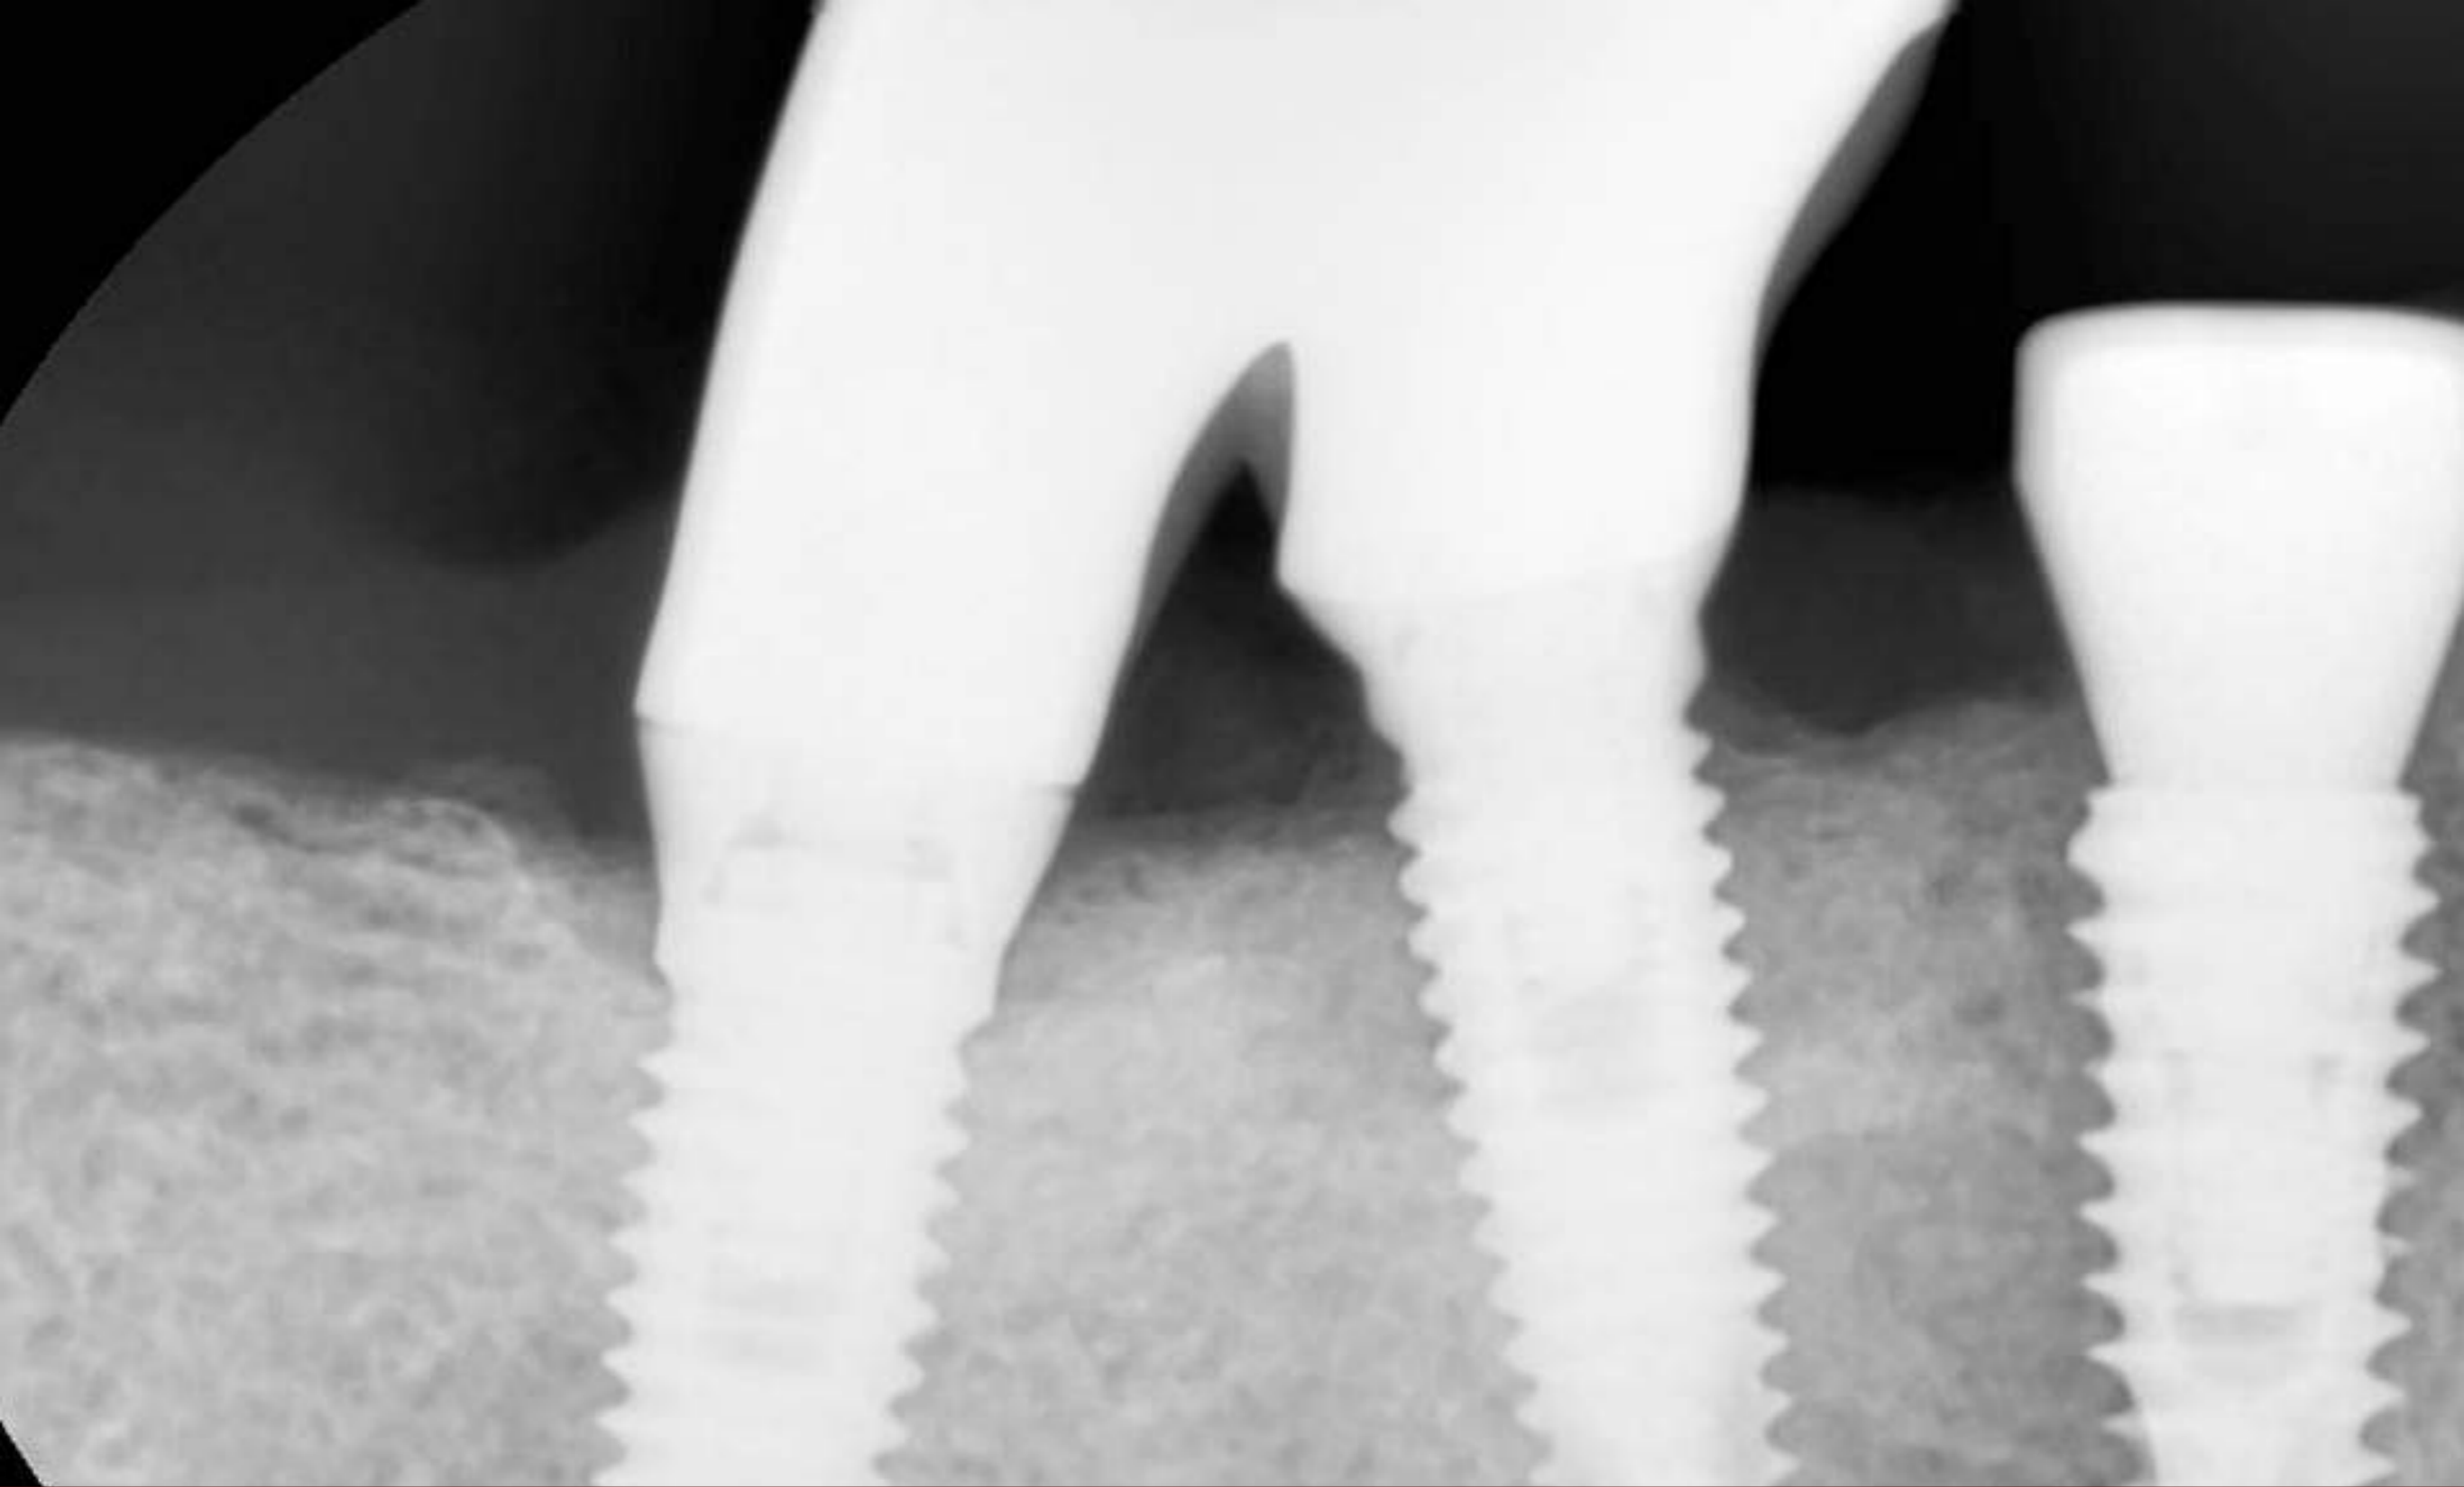
Postoperative radiographic view.

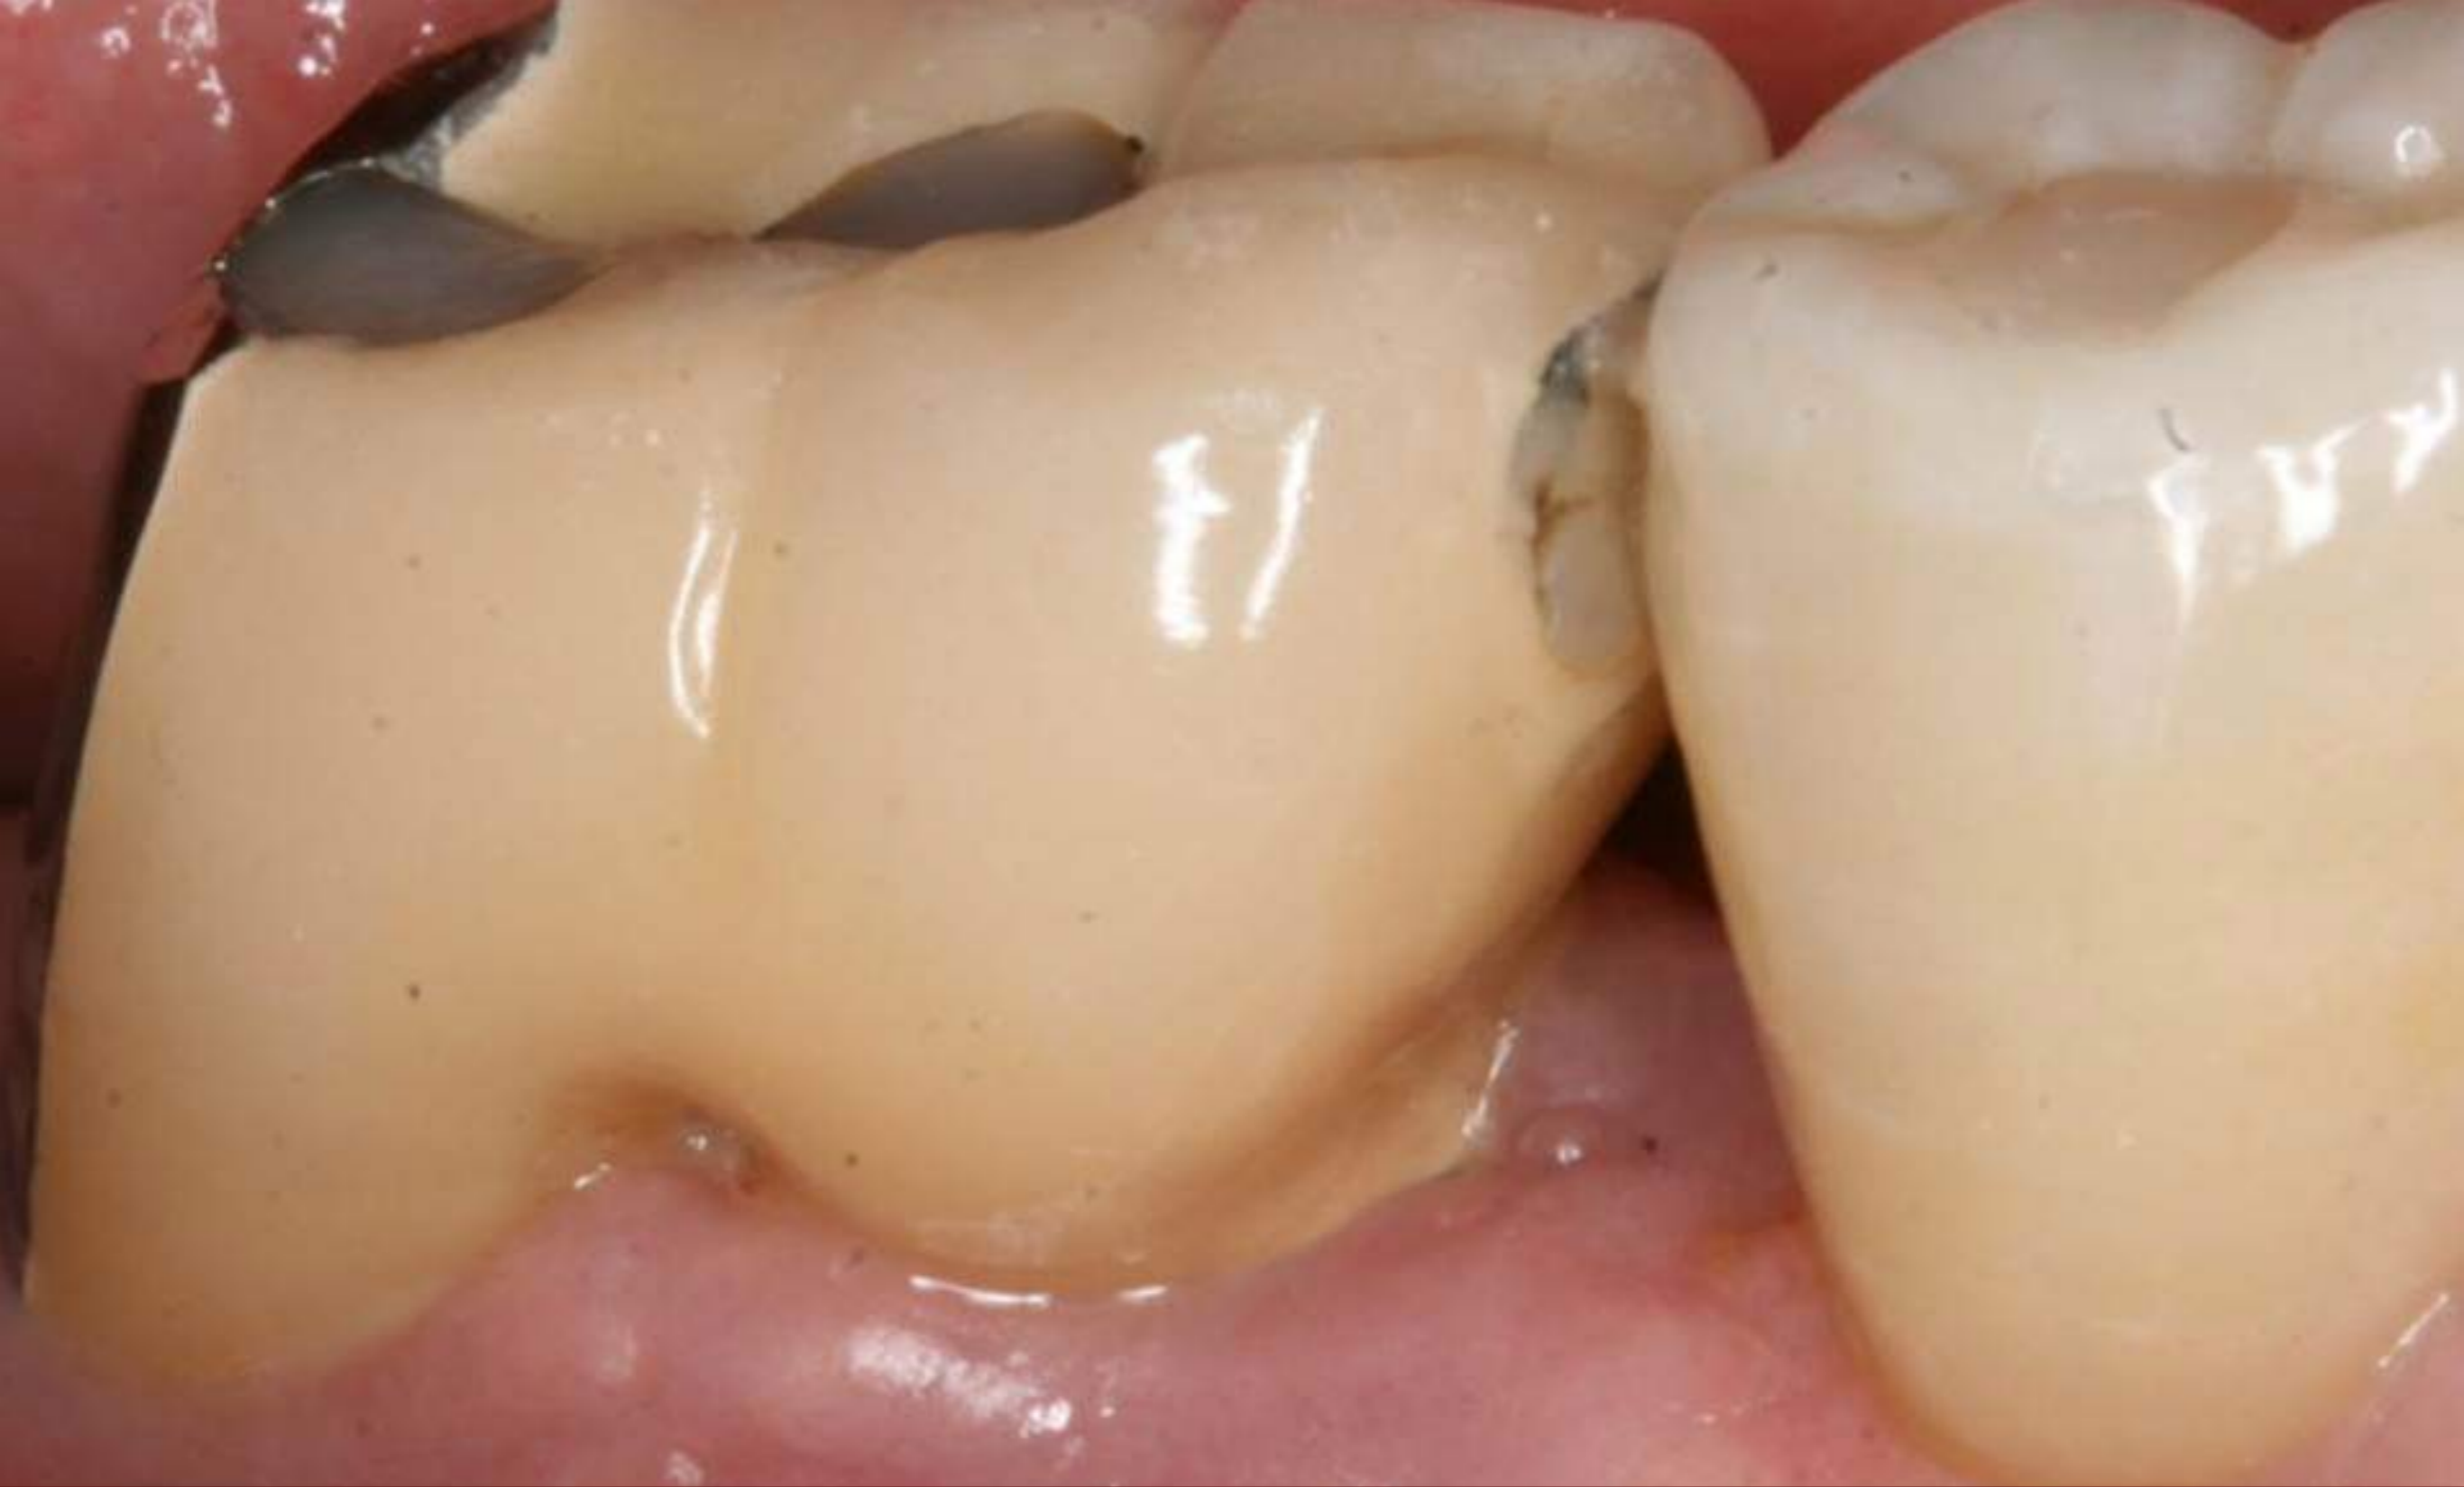
1 year postop. Soft tissue around implants has been maintained without any inflammation signs.
