How to treat Peri-implantitis

R brush Clinical Case

- Peri implantitis treatment solution
- Create New surface
- Titanium Alloy

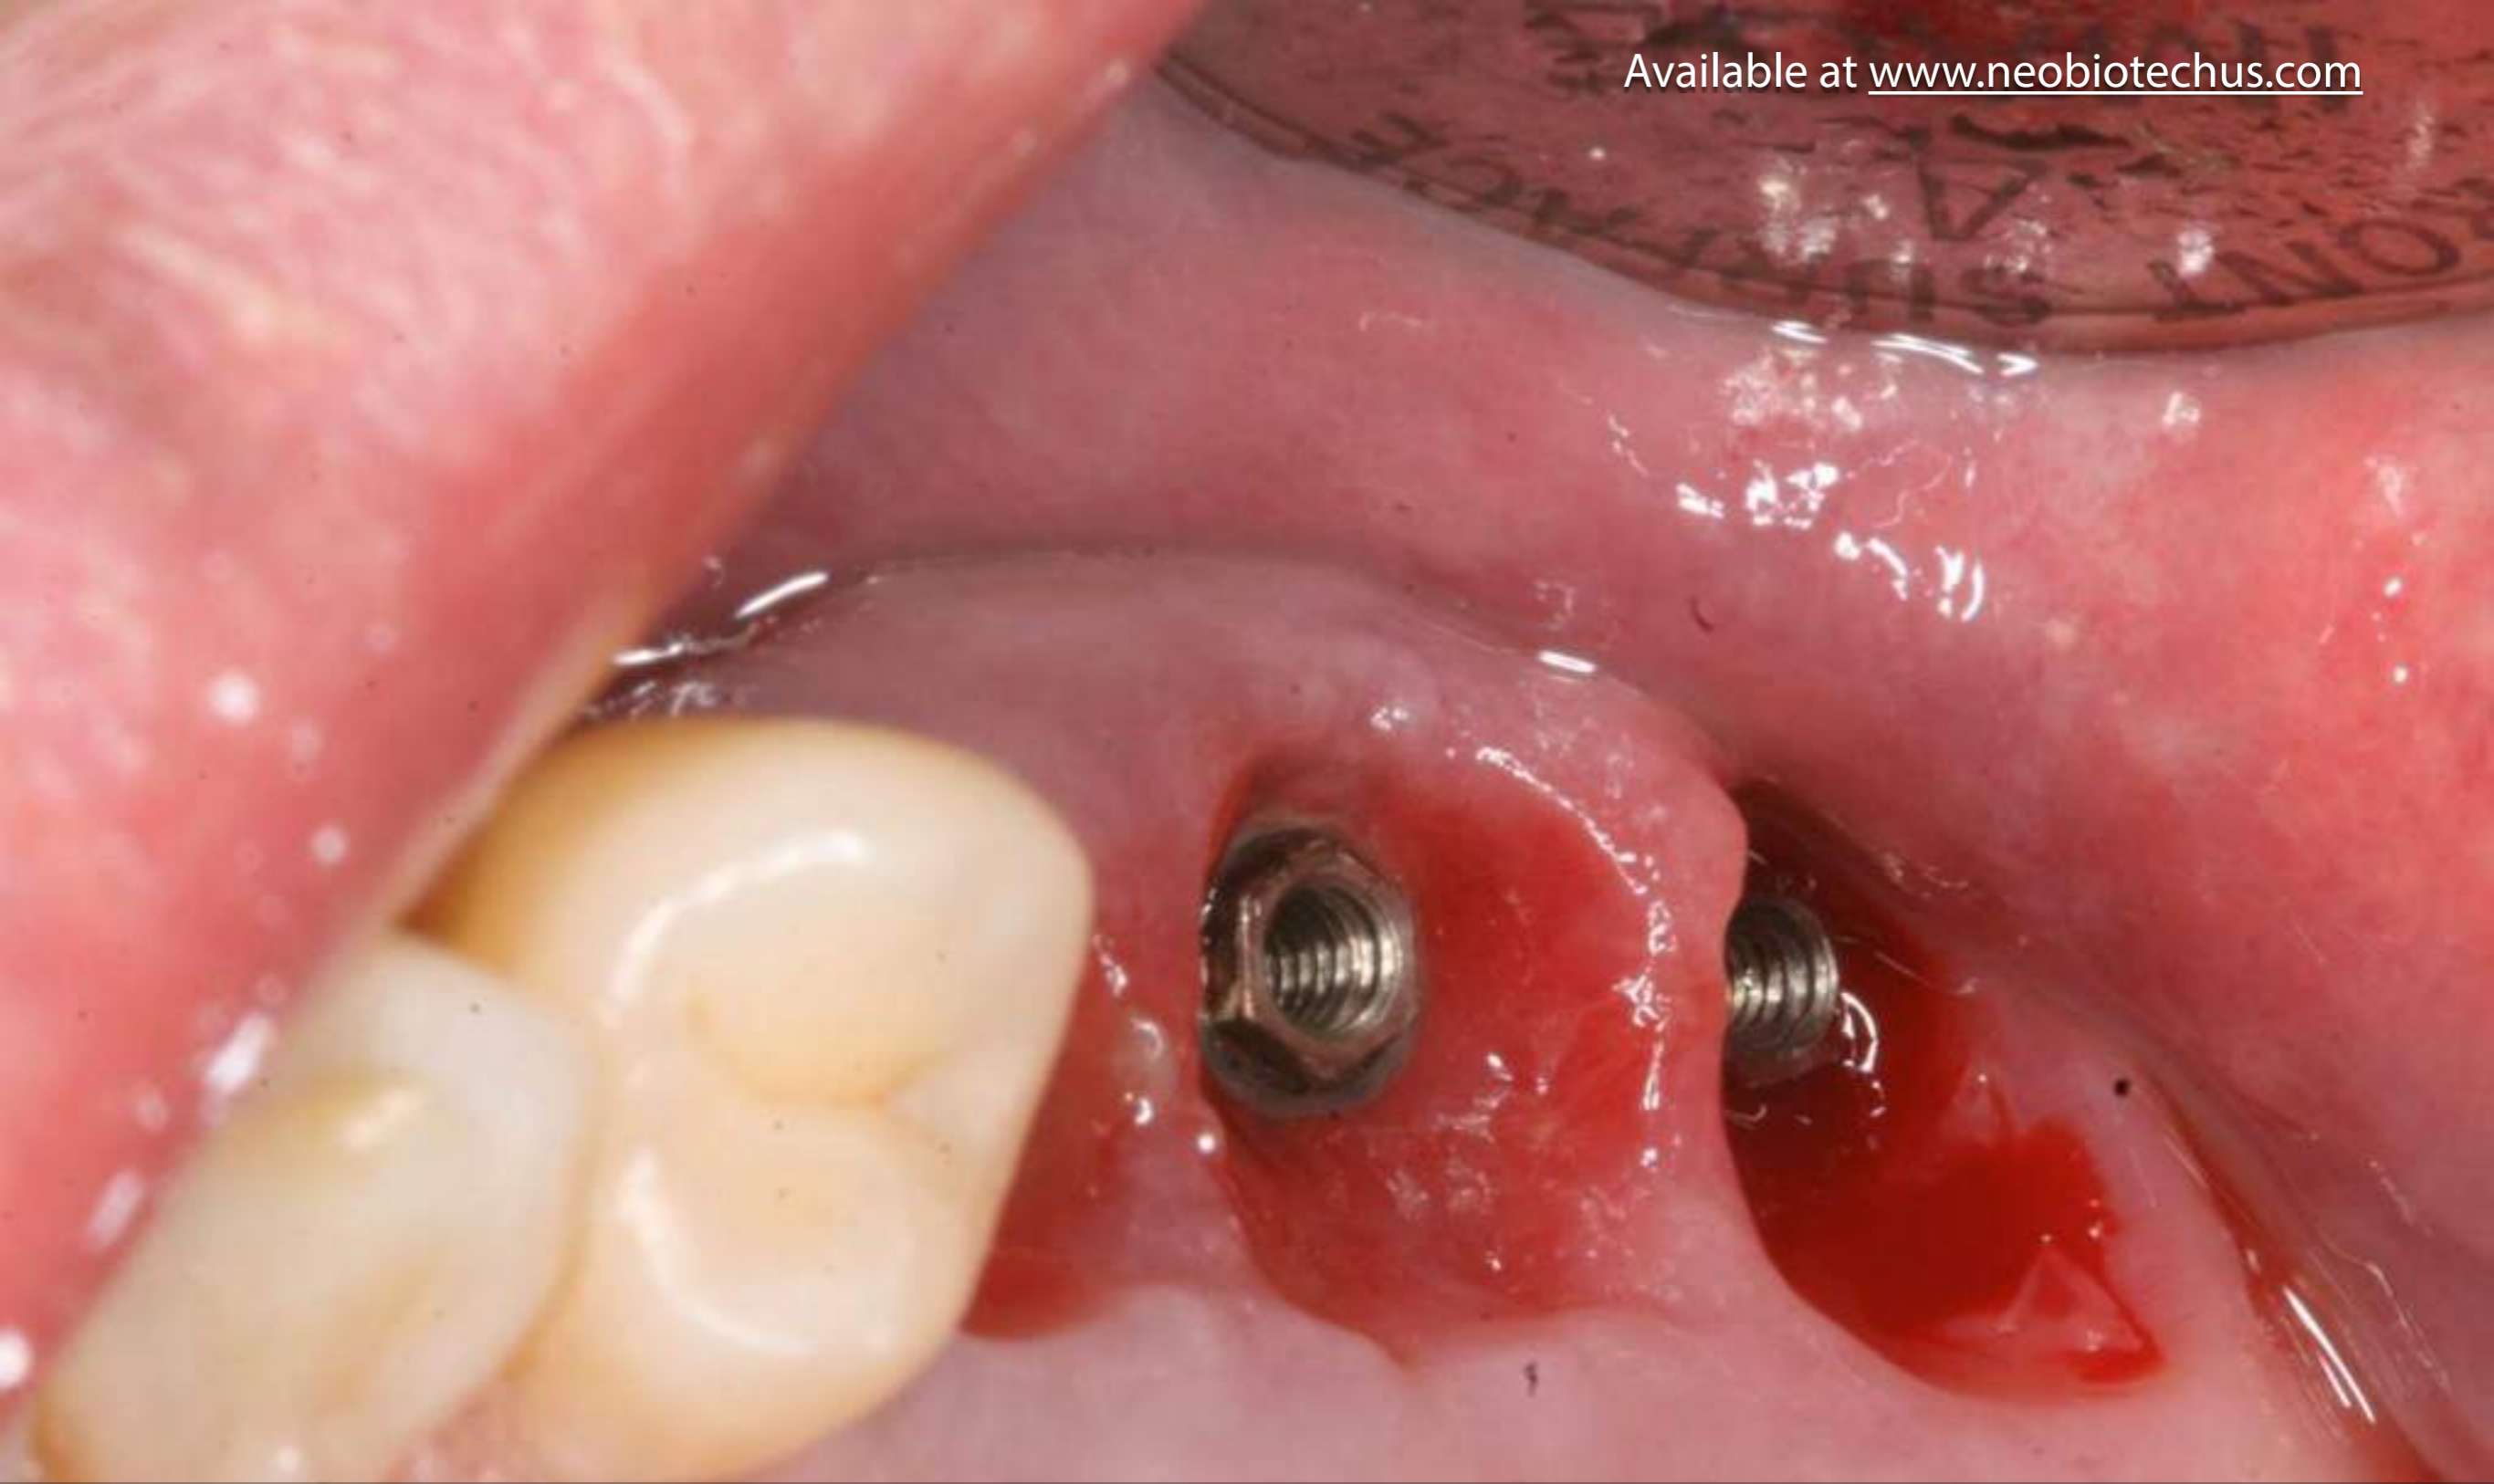
3 Brånemark type external implants were placed in the left maxillary posterior area with sinus graft (left). 8 years later, an advanced chronic periimplantitis with severe bone loss around the implant was found in the middle implant area (right).

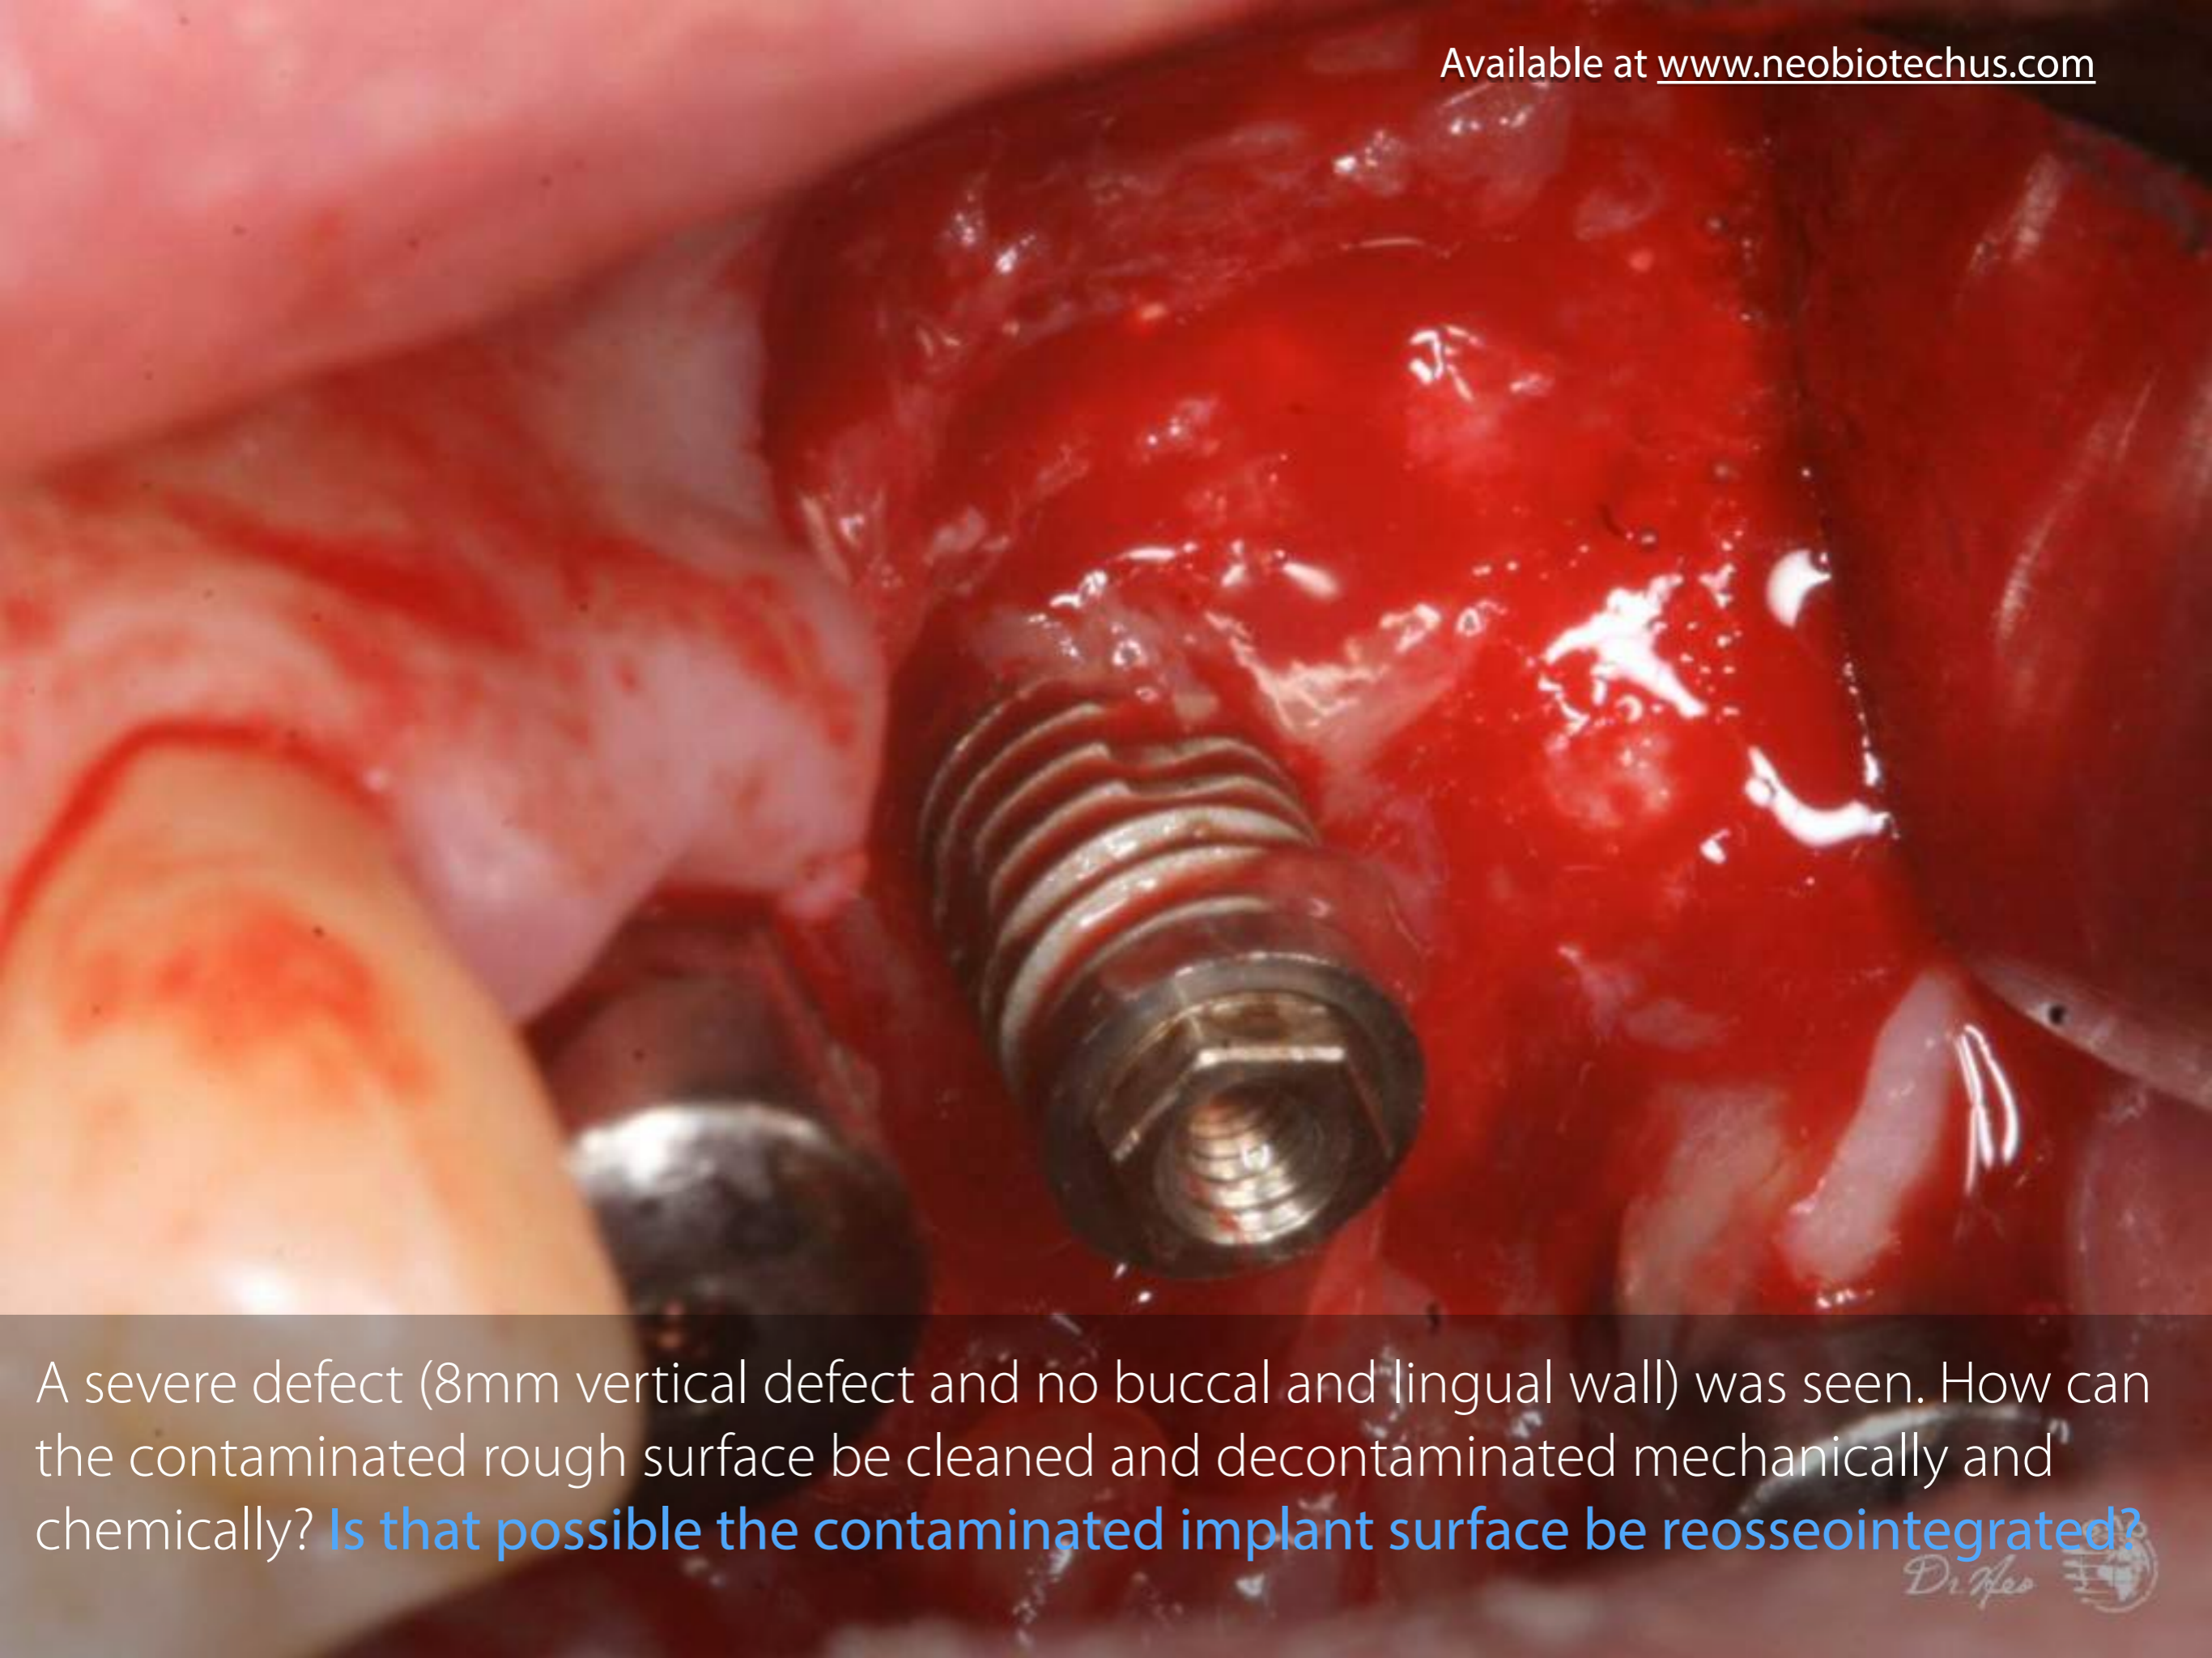
The 3 unit SCRCP (Screw & Cement Retained Prosthesis) was removed through the screw holes. Soft tissue around the bridge looked fine.

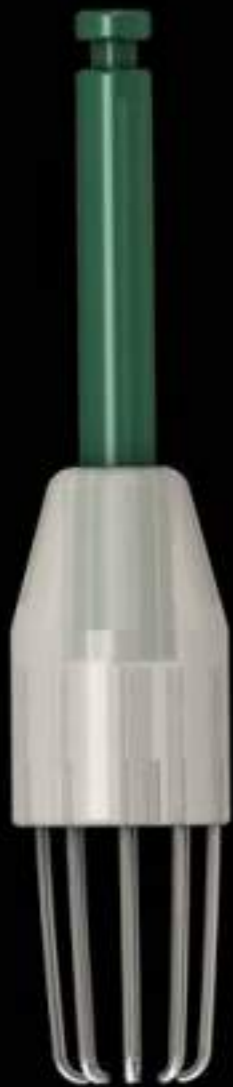
A regular size of R-Brush (Neobiotech, Korea) was used to decontaminate the contaminated rough surface mechanically.

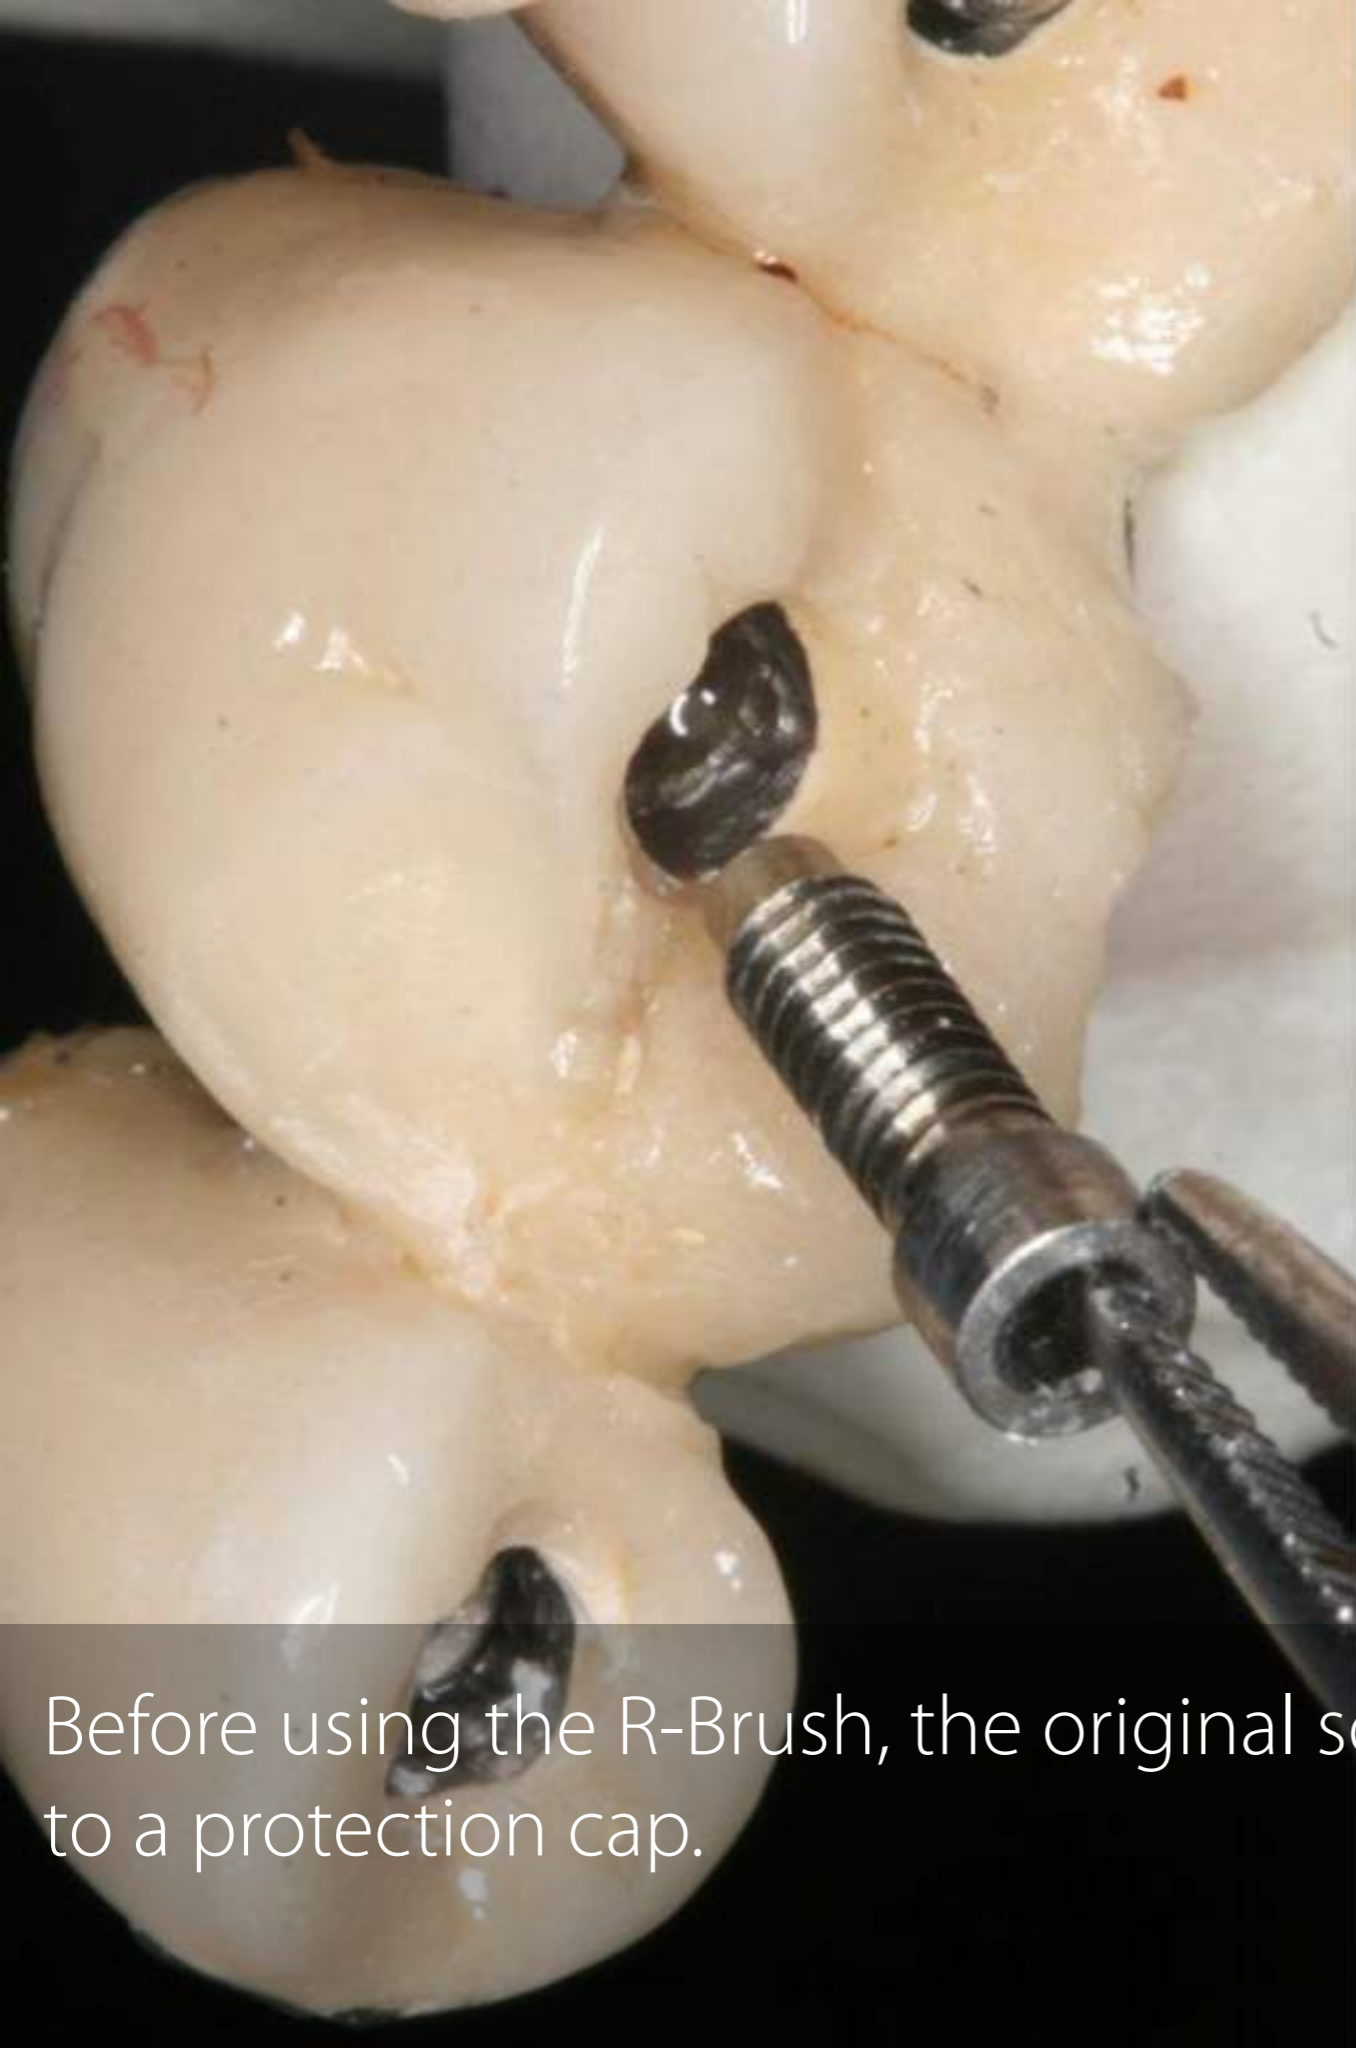
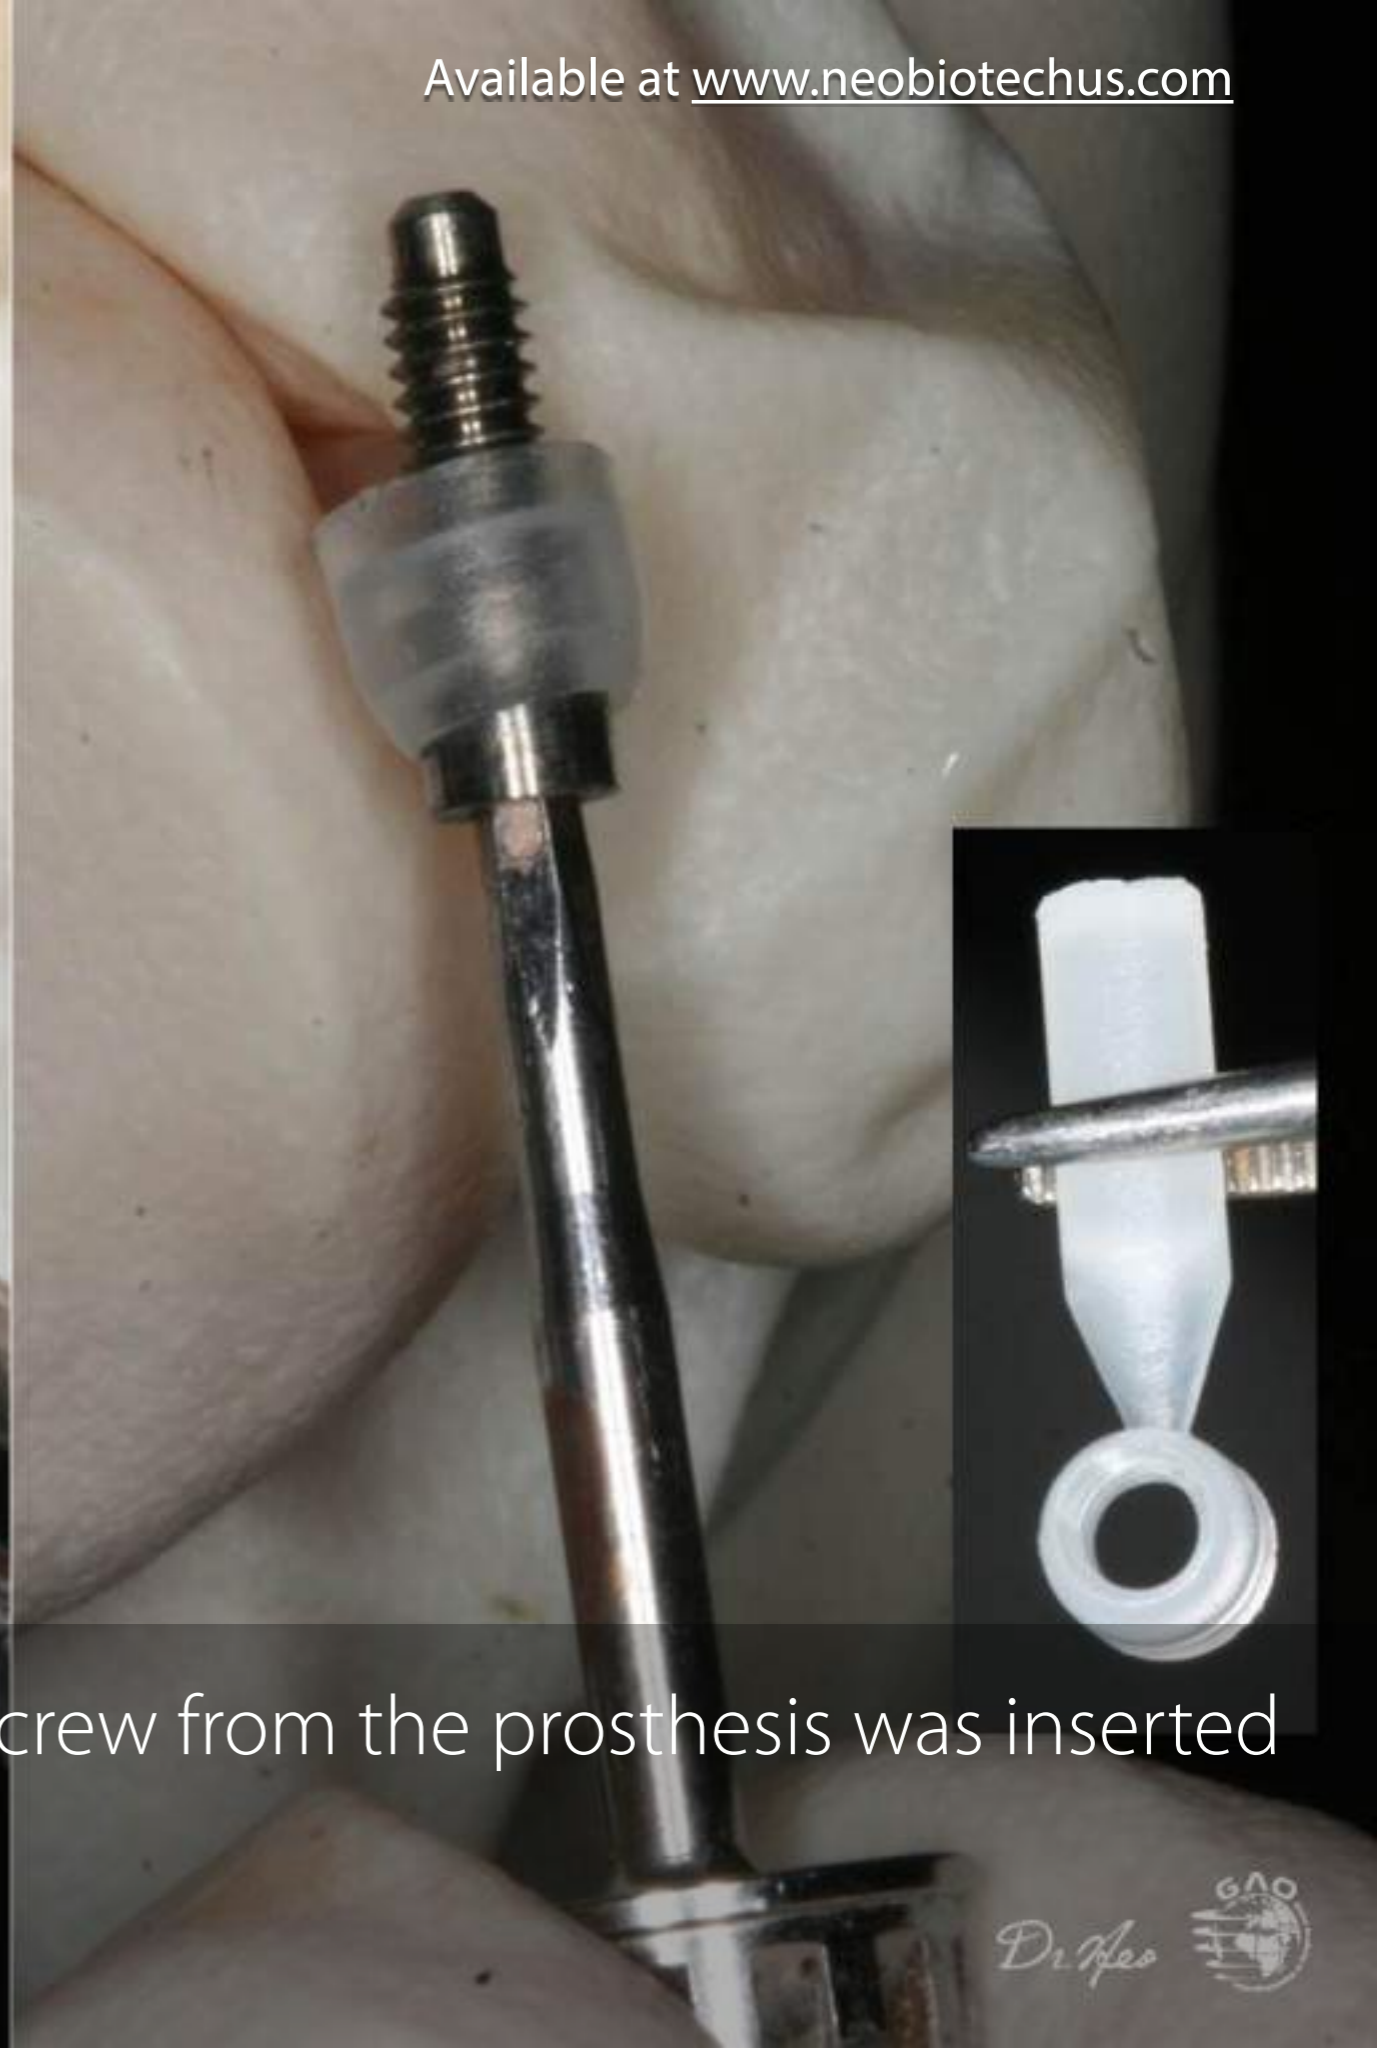
Before using the R-Brush, the original screw from the prosthesis was inserted to a protection cap.

The Protection cap was connected to the screw hole to prevent the bristle to go into the screw hole.

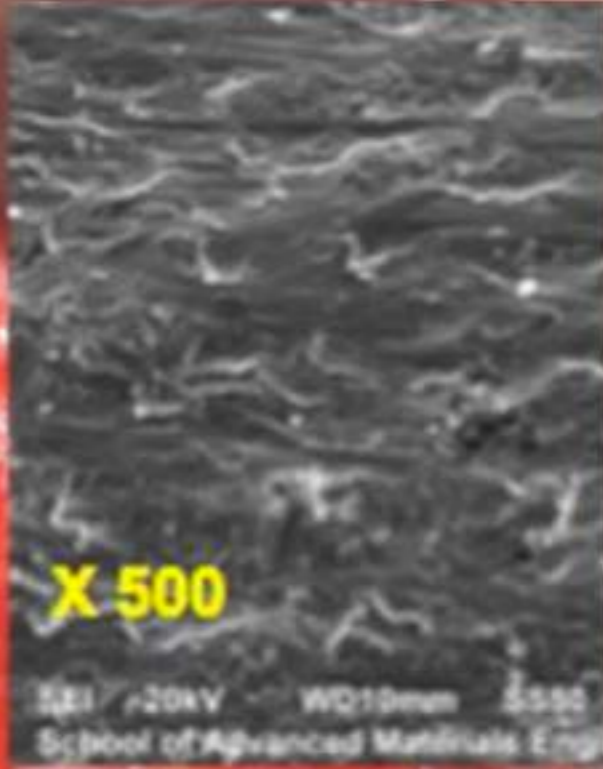
A regular size of R-Brush was connected to a 1:1 contra-angle and rotated using a speed of around **8000 rpm(or2000rpm)** with copious water or chlorhexidine solution. 30 to 60 seconds were taken to clean one thread. It took about 5 minutes to clean 8 threads.

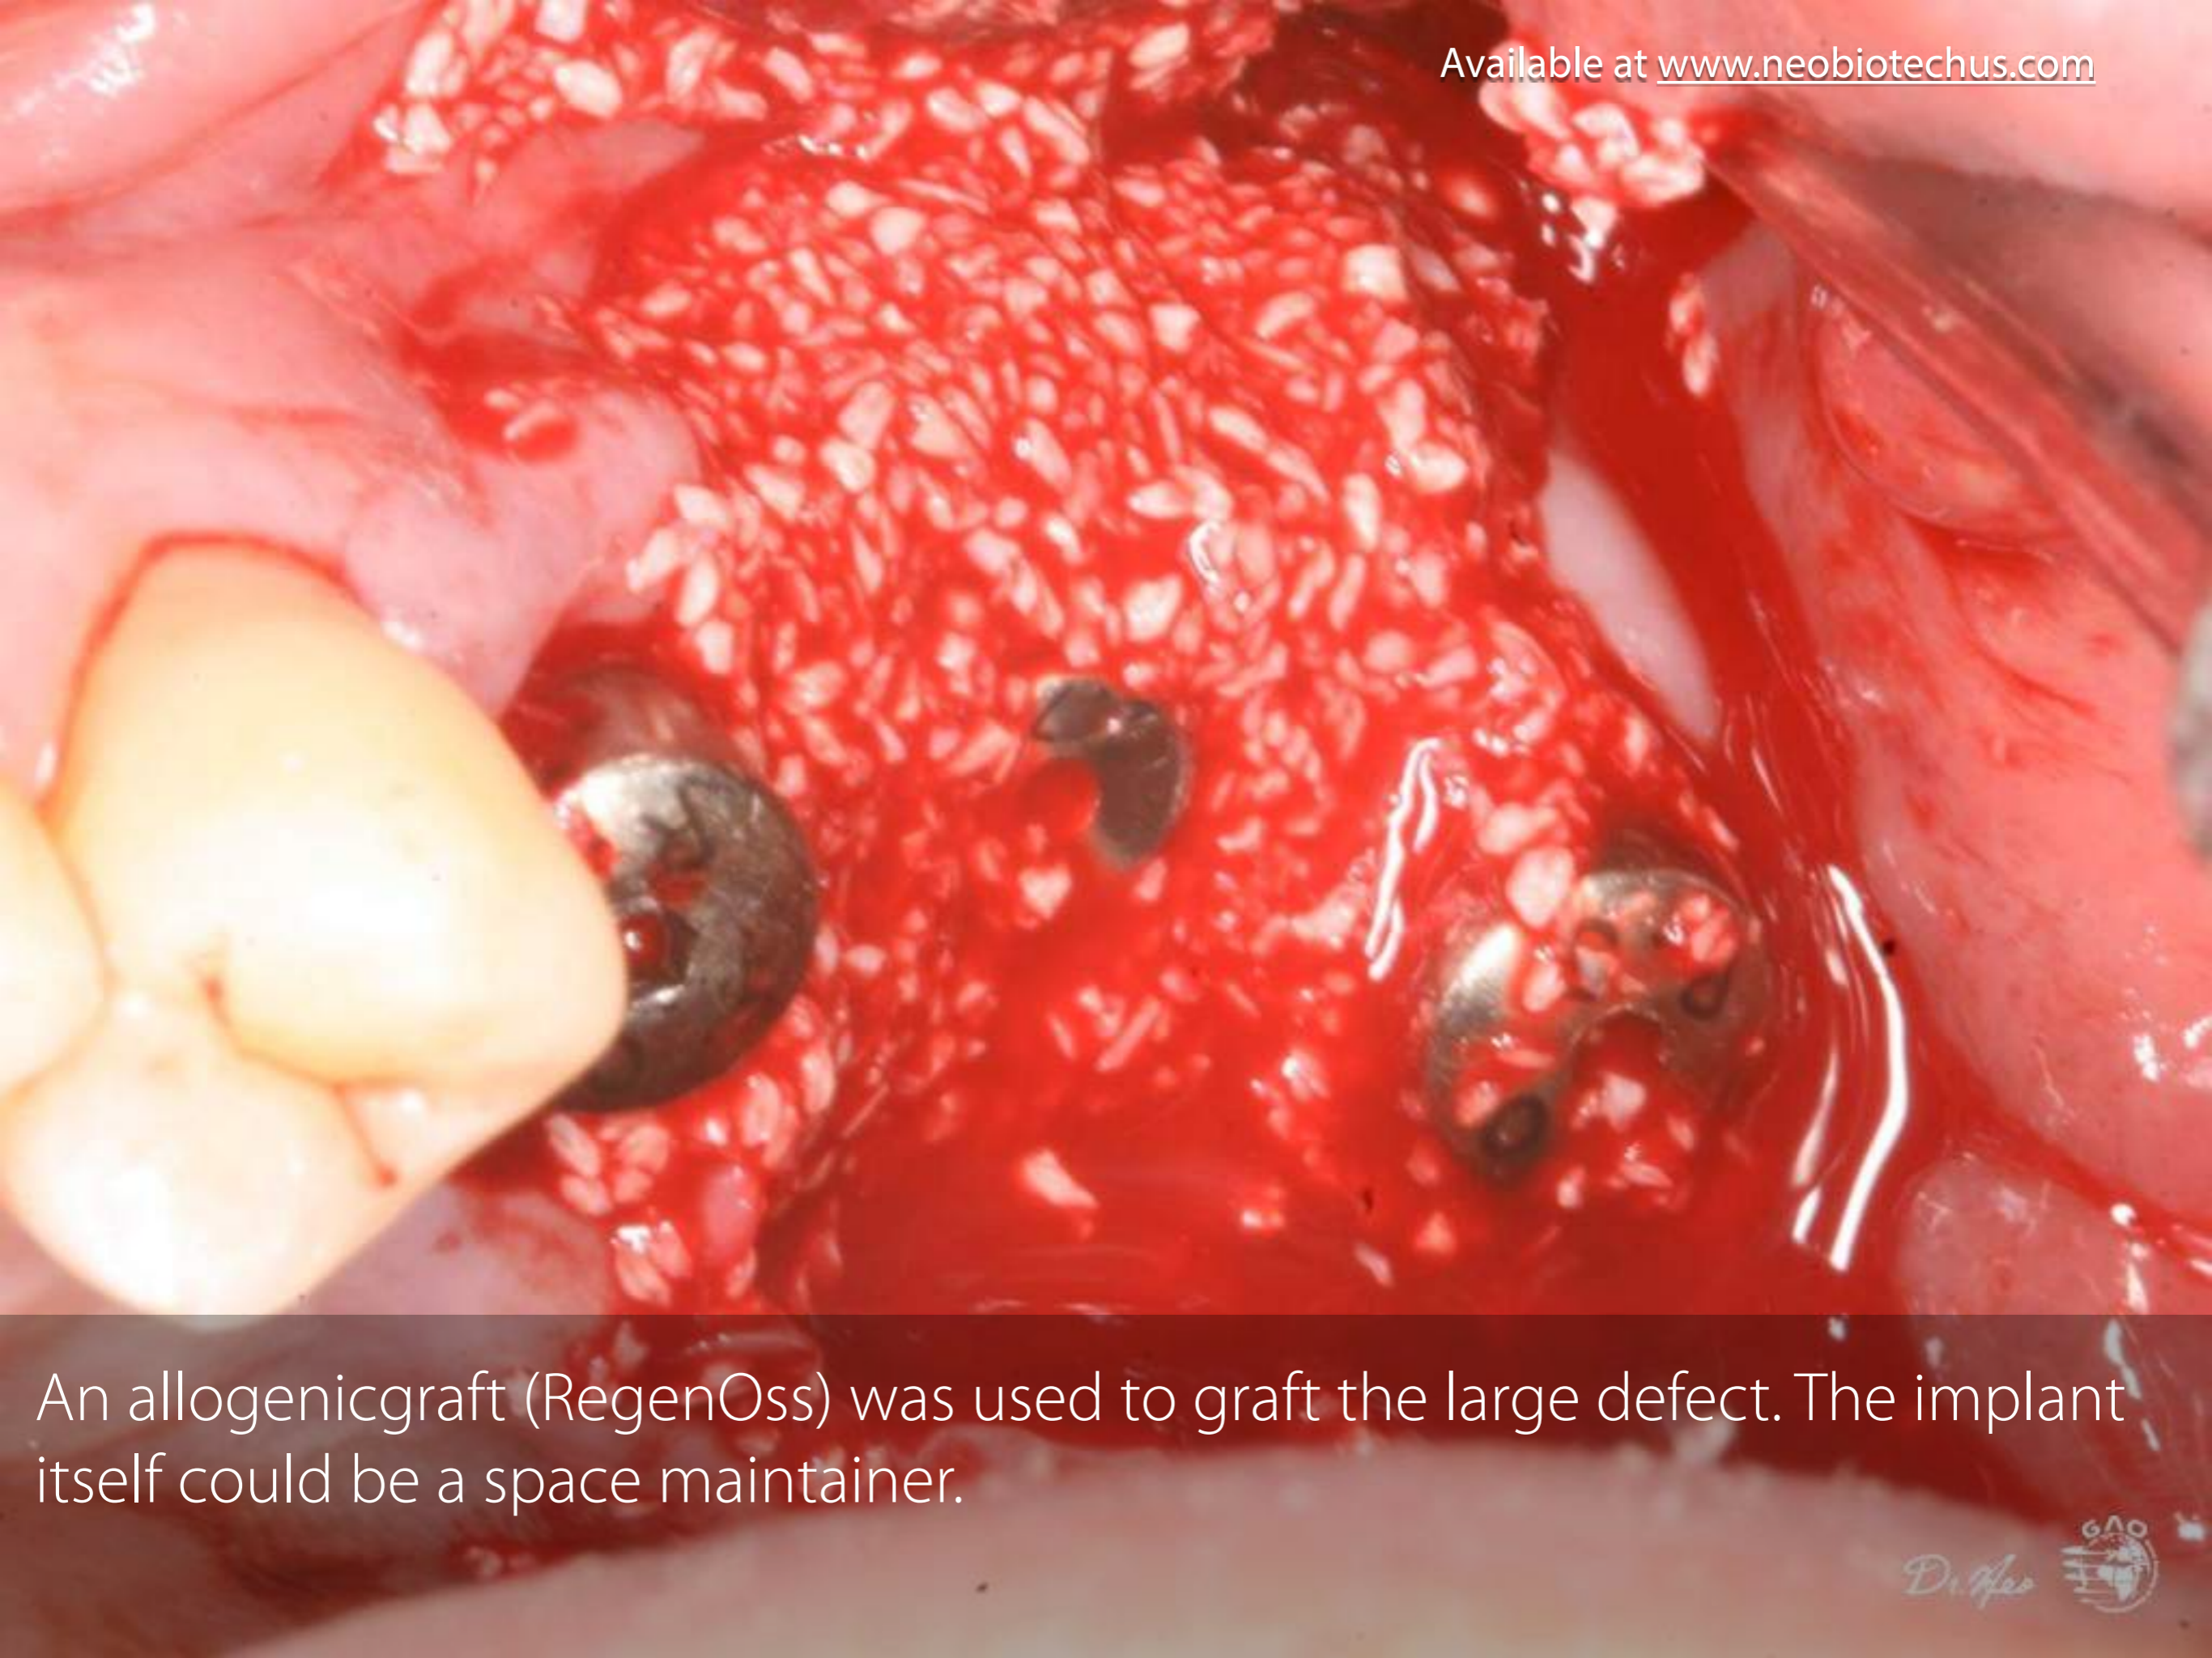
A clean surface like a machine surface was seen. It is known that the R-Brush could eliminate the original surface and **create a new rough surface** which is not like machine surface but like new rough surface having Ra: 1-1.2.

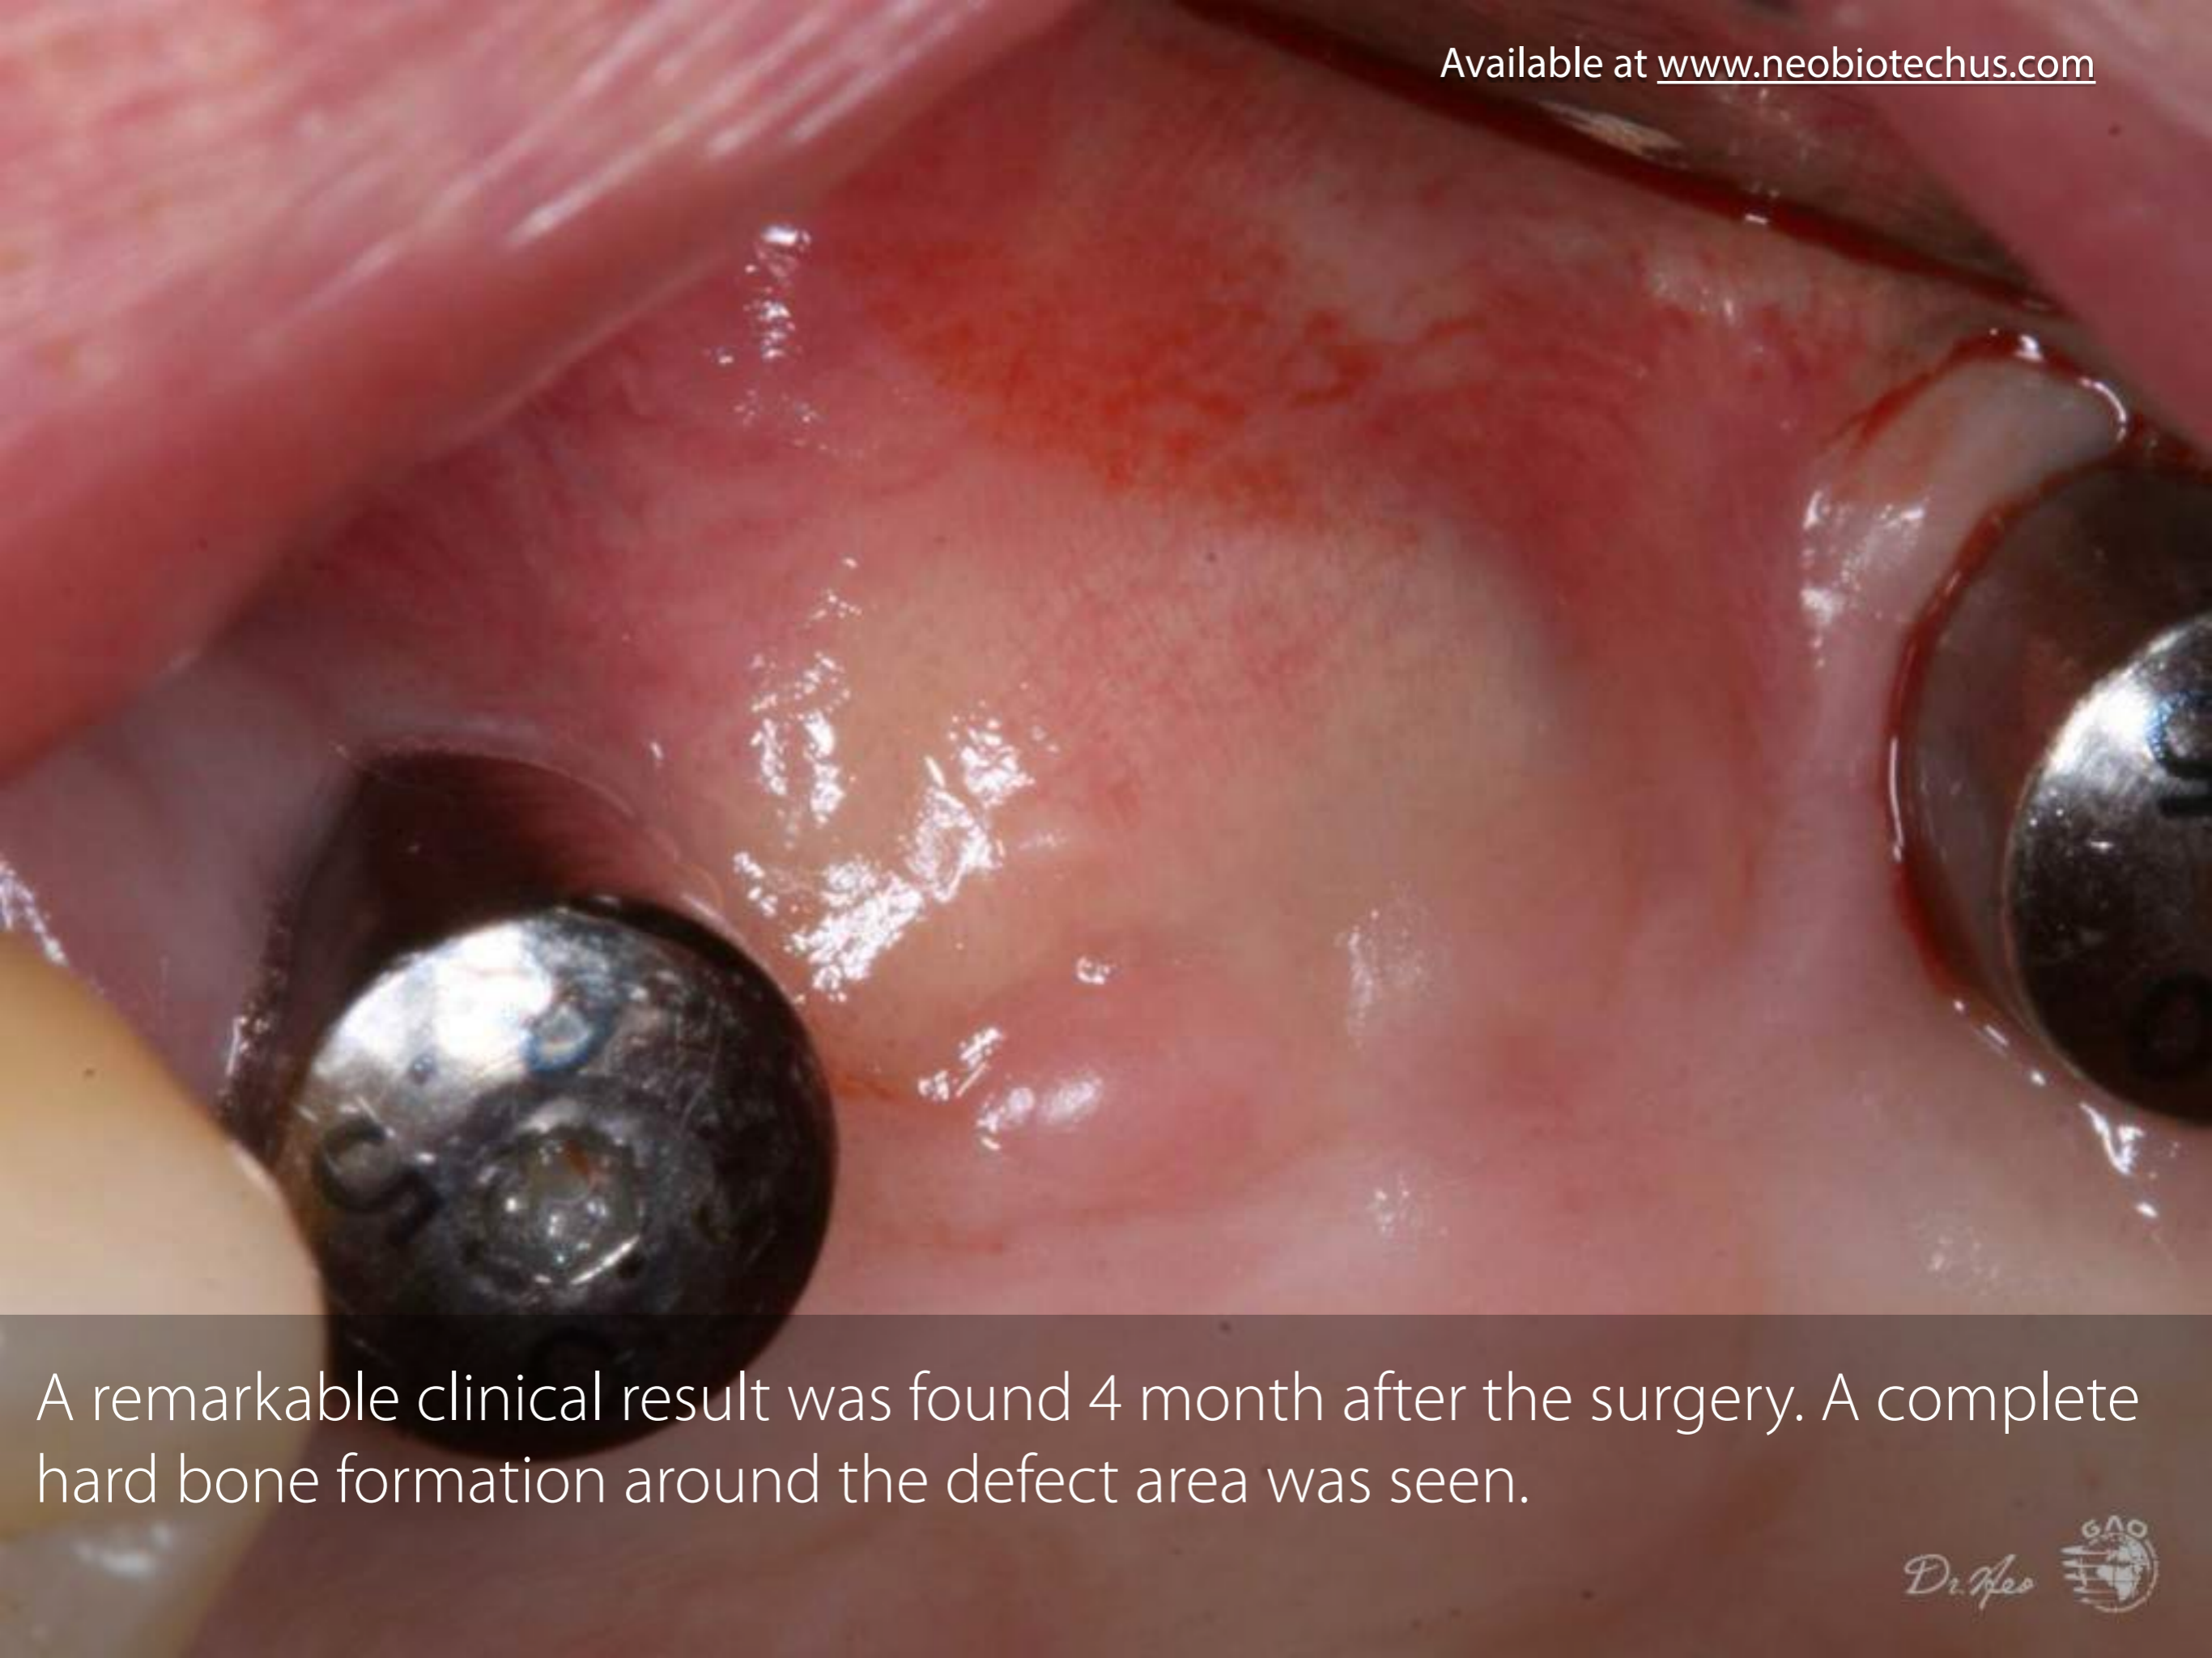
A radiograph right after the surgery.
