How to treat Peri-implantitis

R brush Clinical Case

- Peri implantitis treatment solution
- Create New surface
- Titanium Alloy

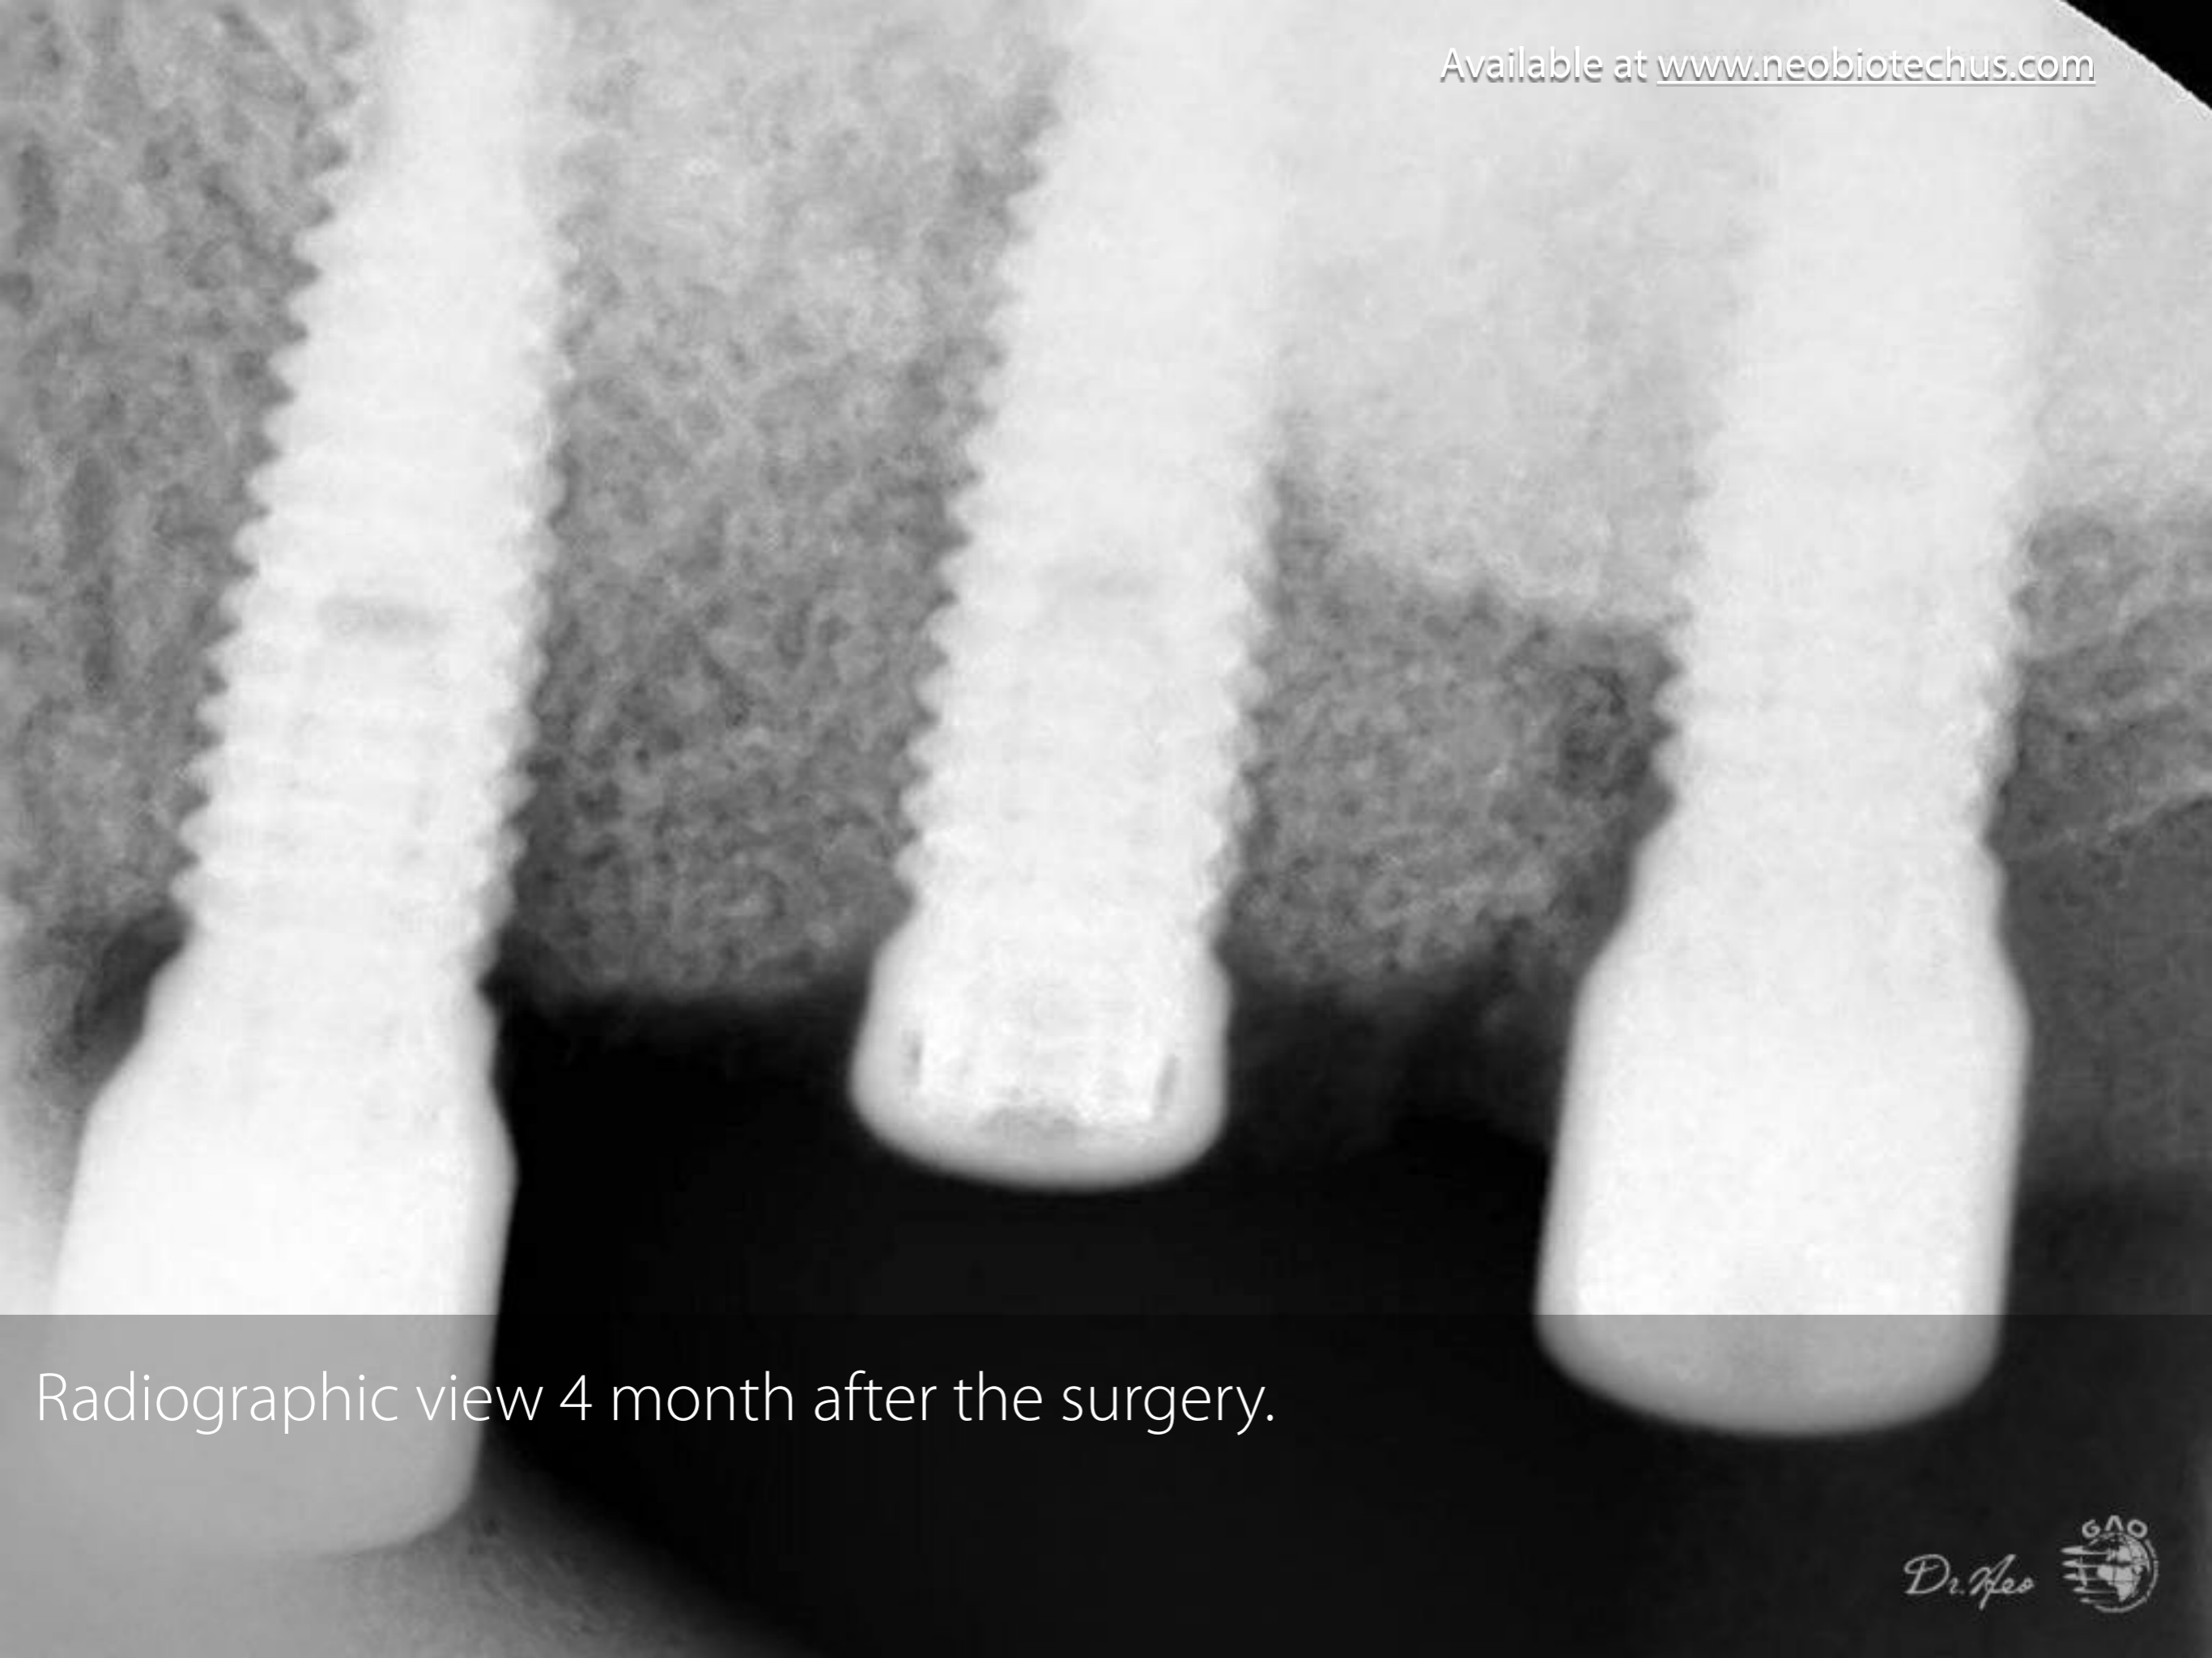
A remarkable clinical result was found 4 month after the surgery. A complete hard bone formation around the defect area was seen.

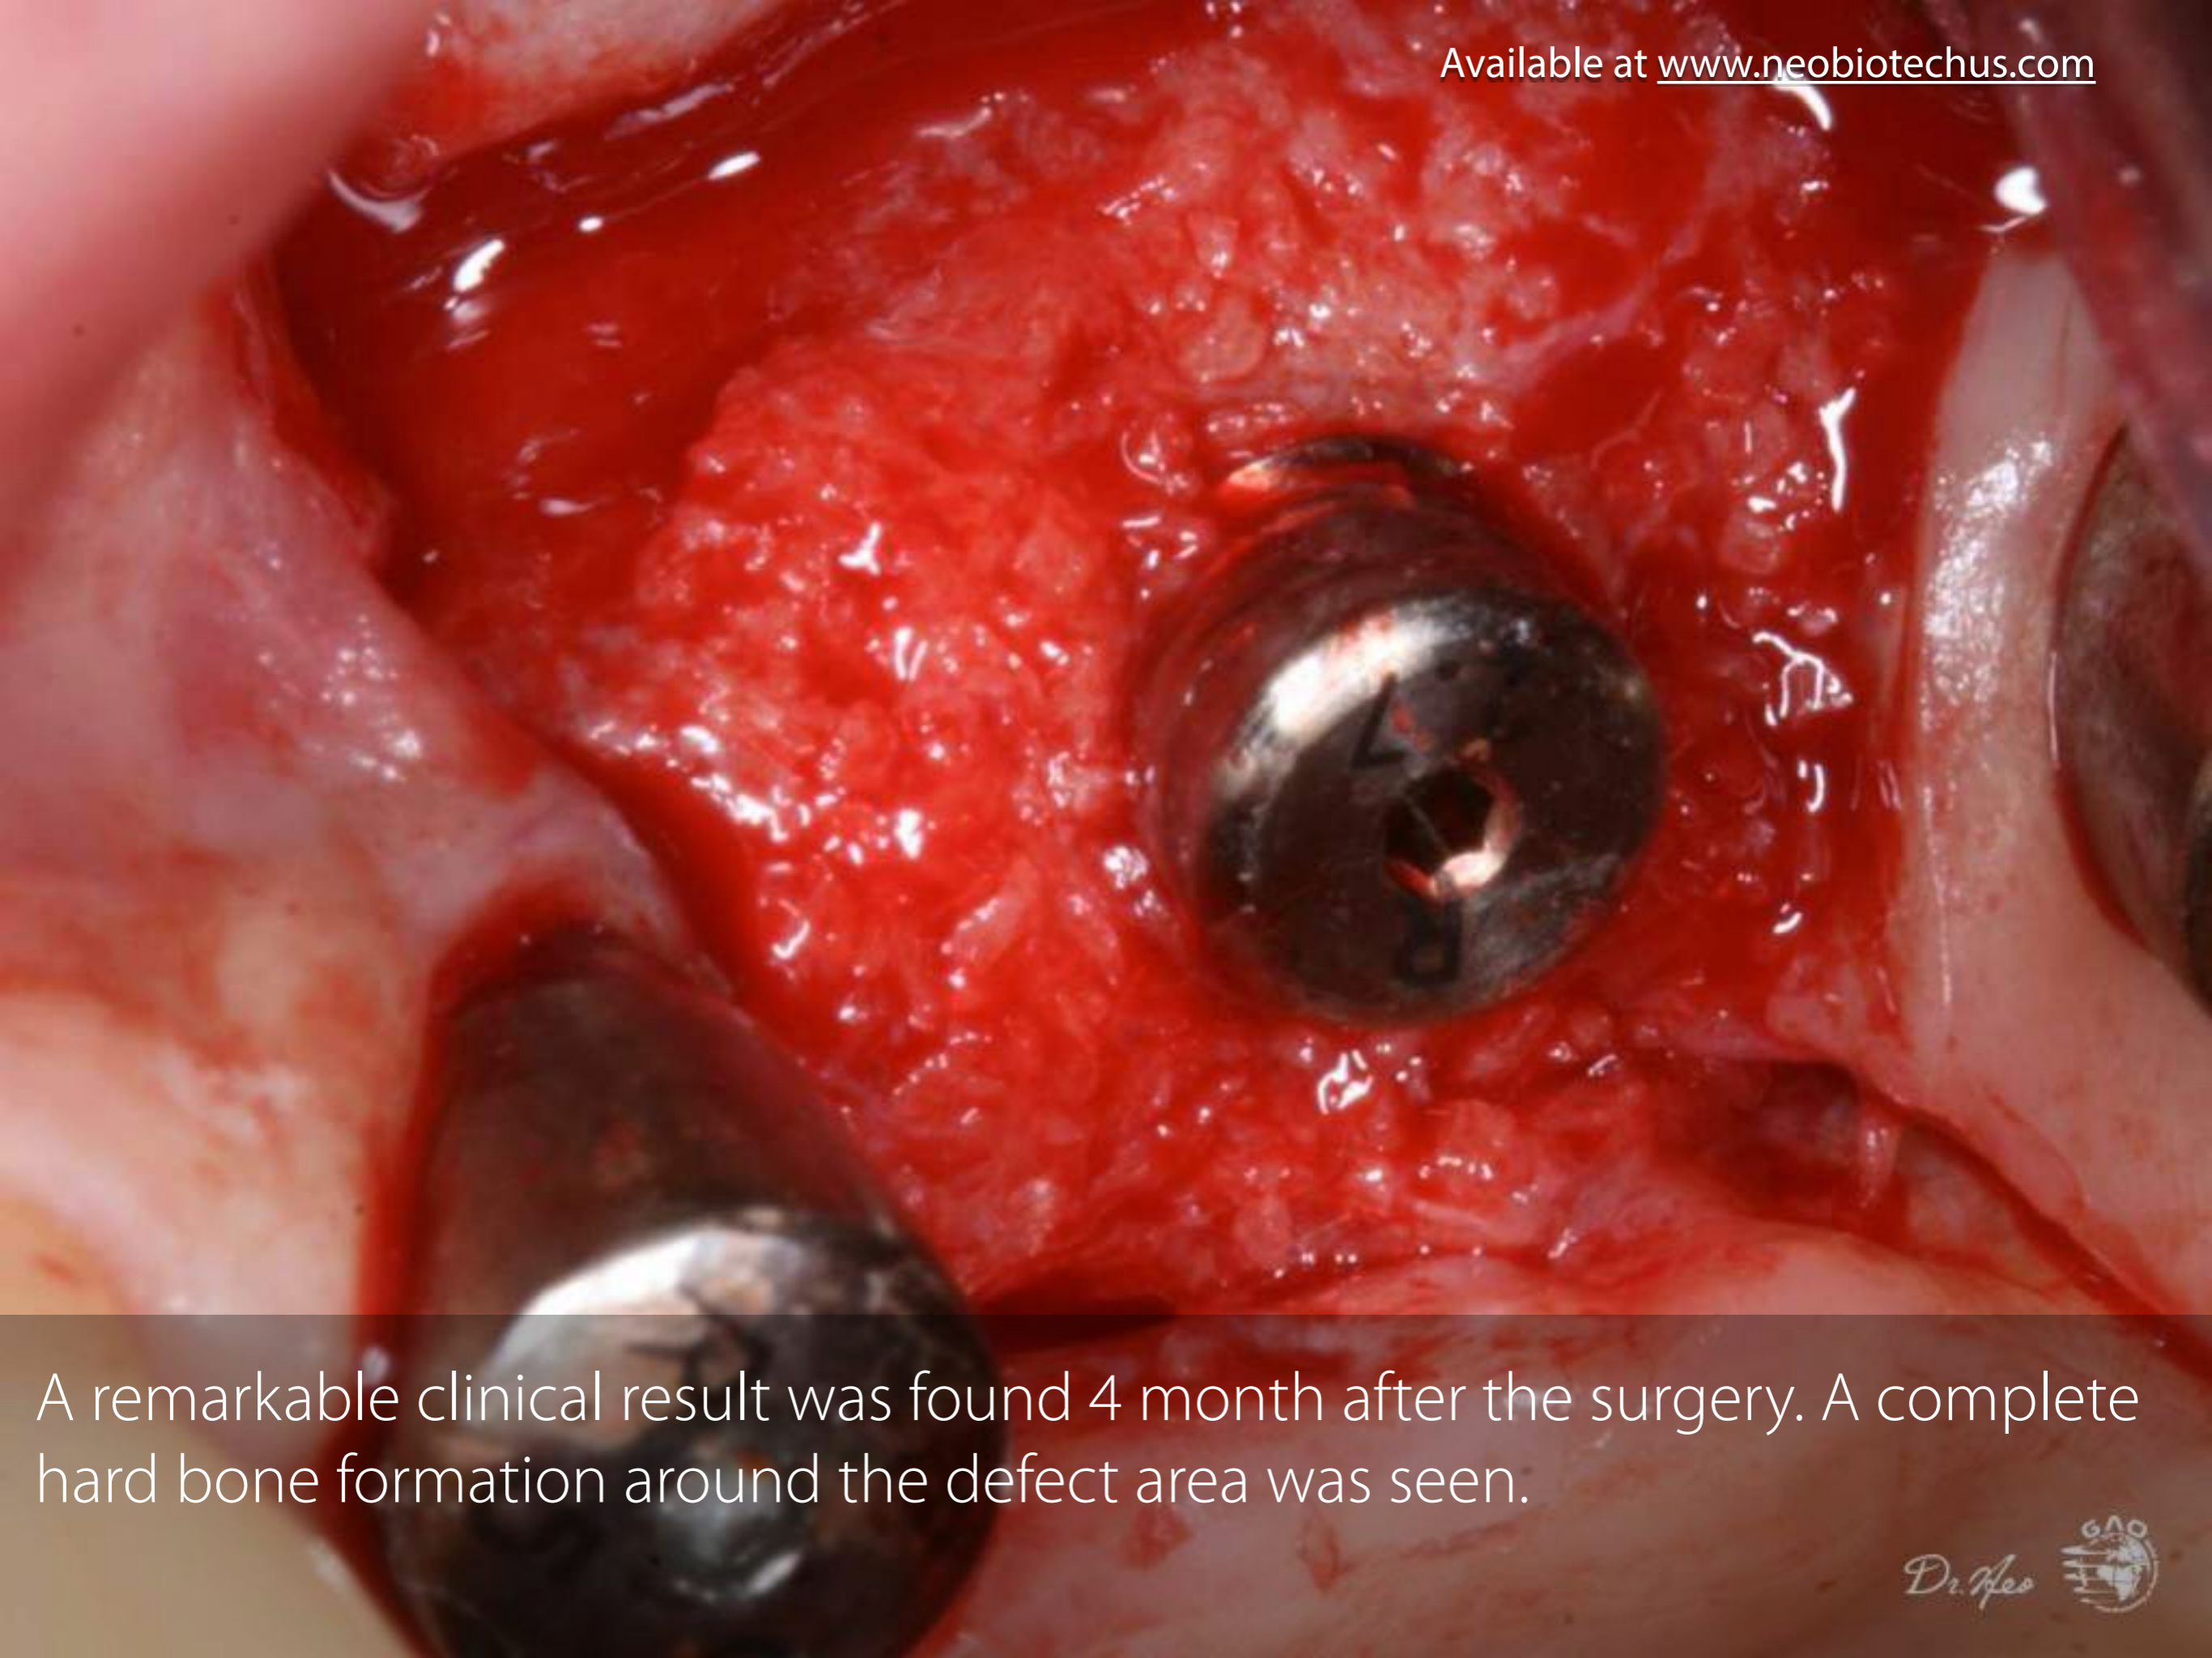
Radiographic view 4 month after the surgery.

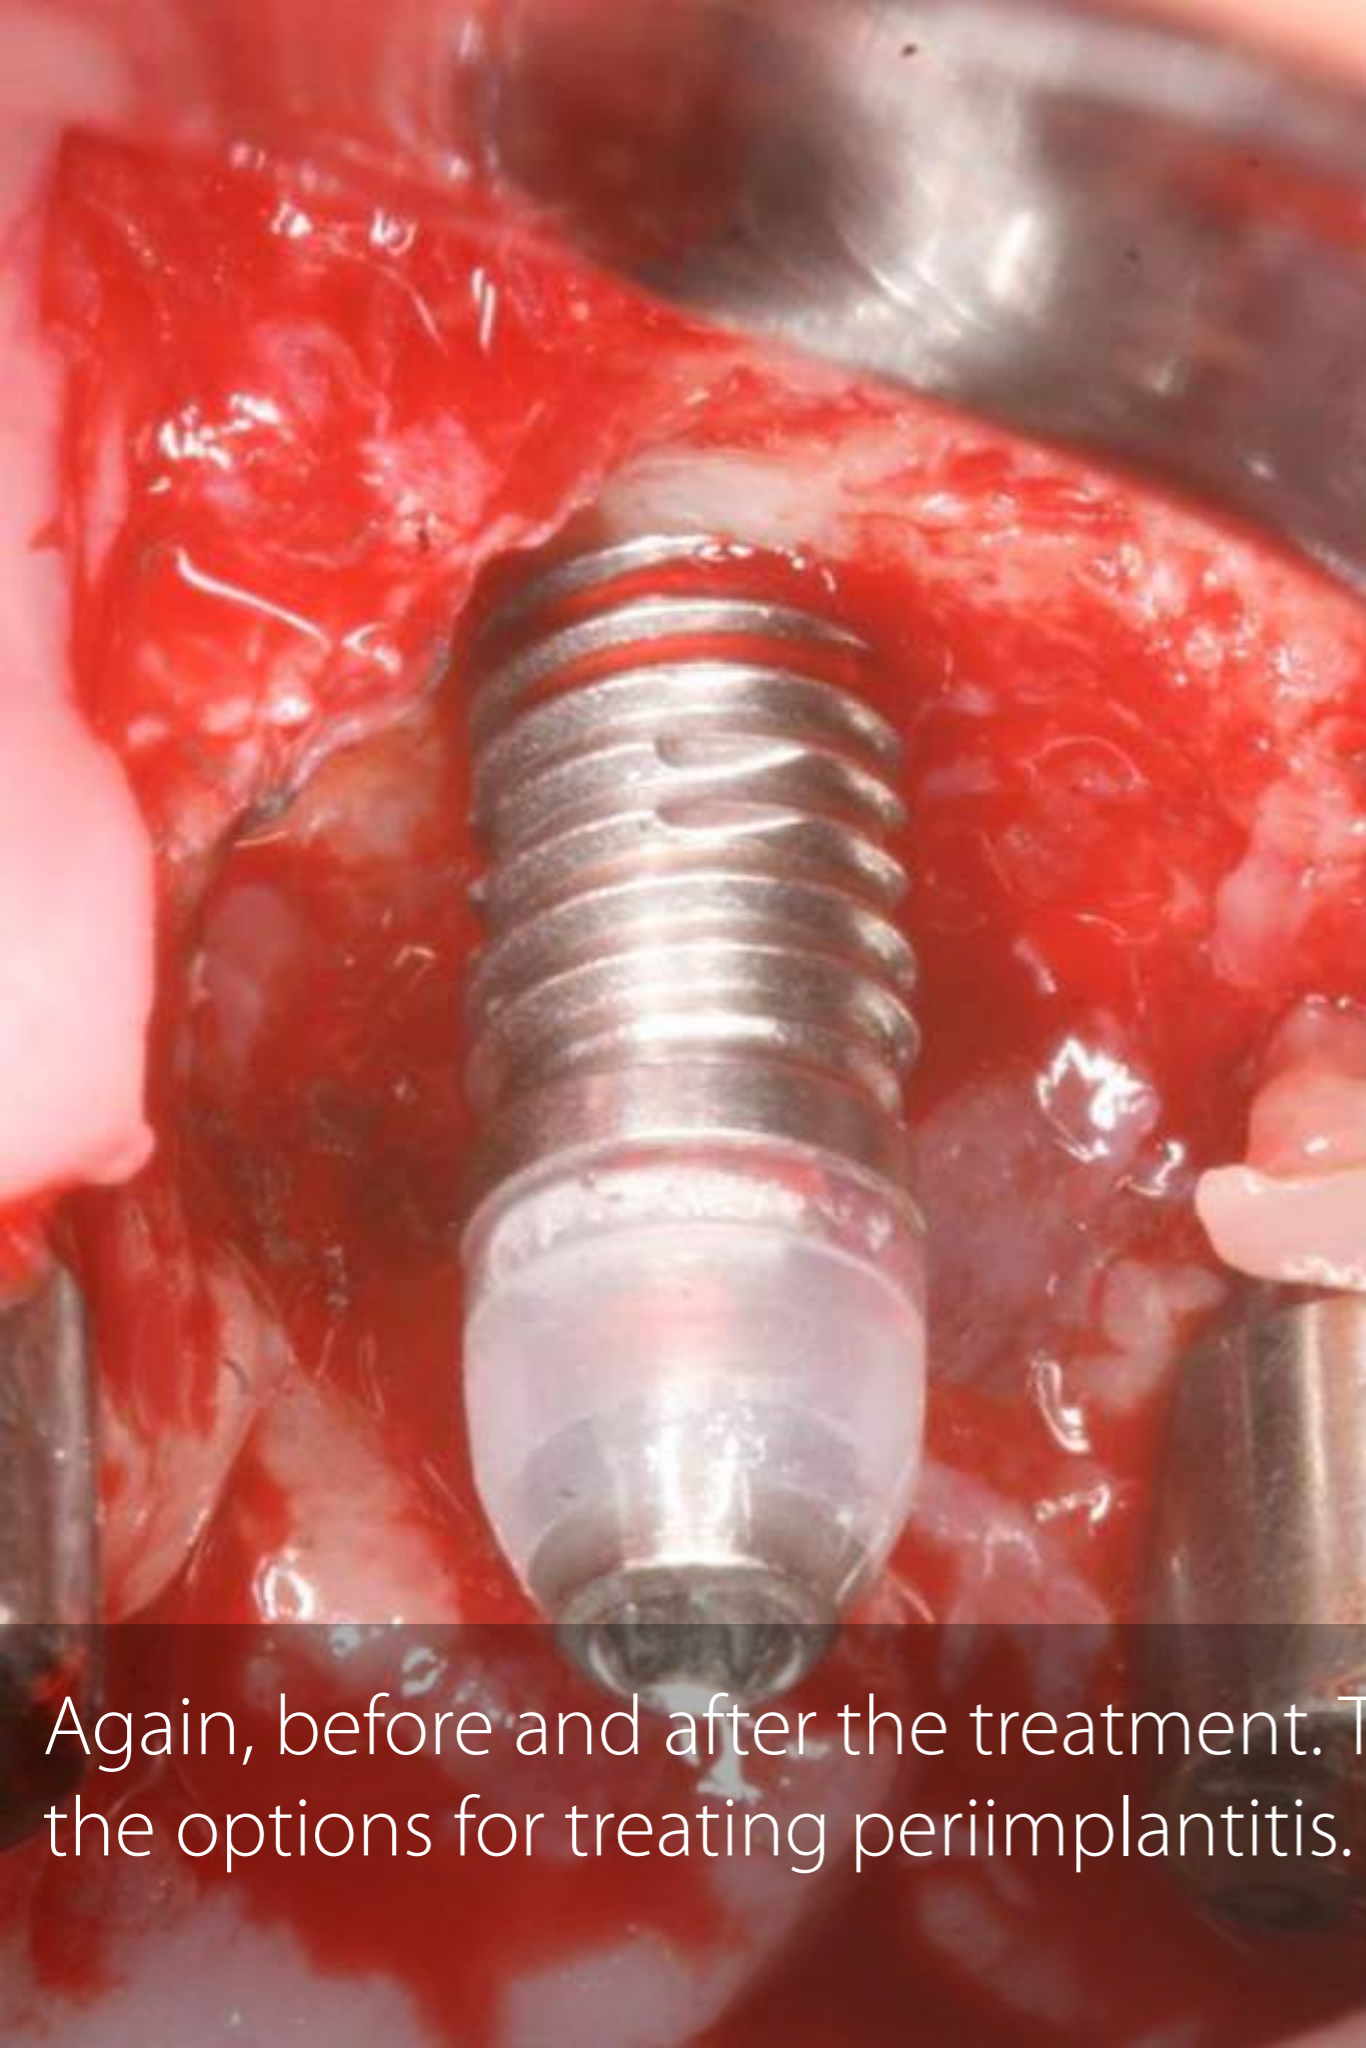
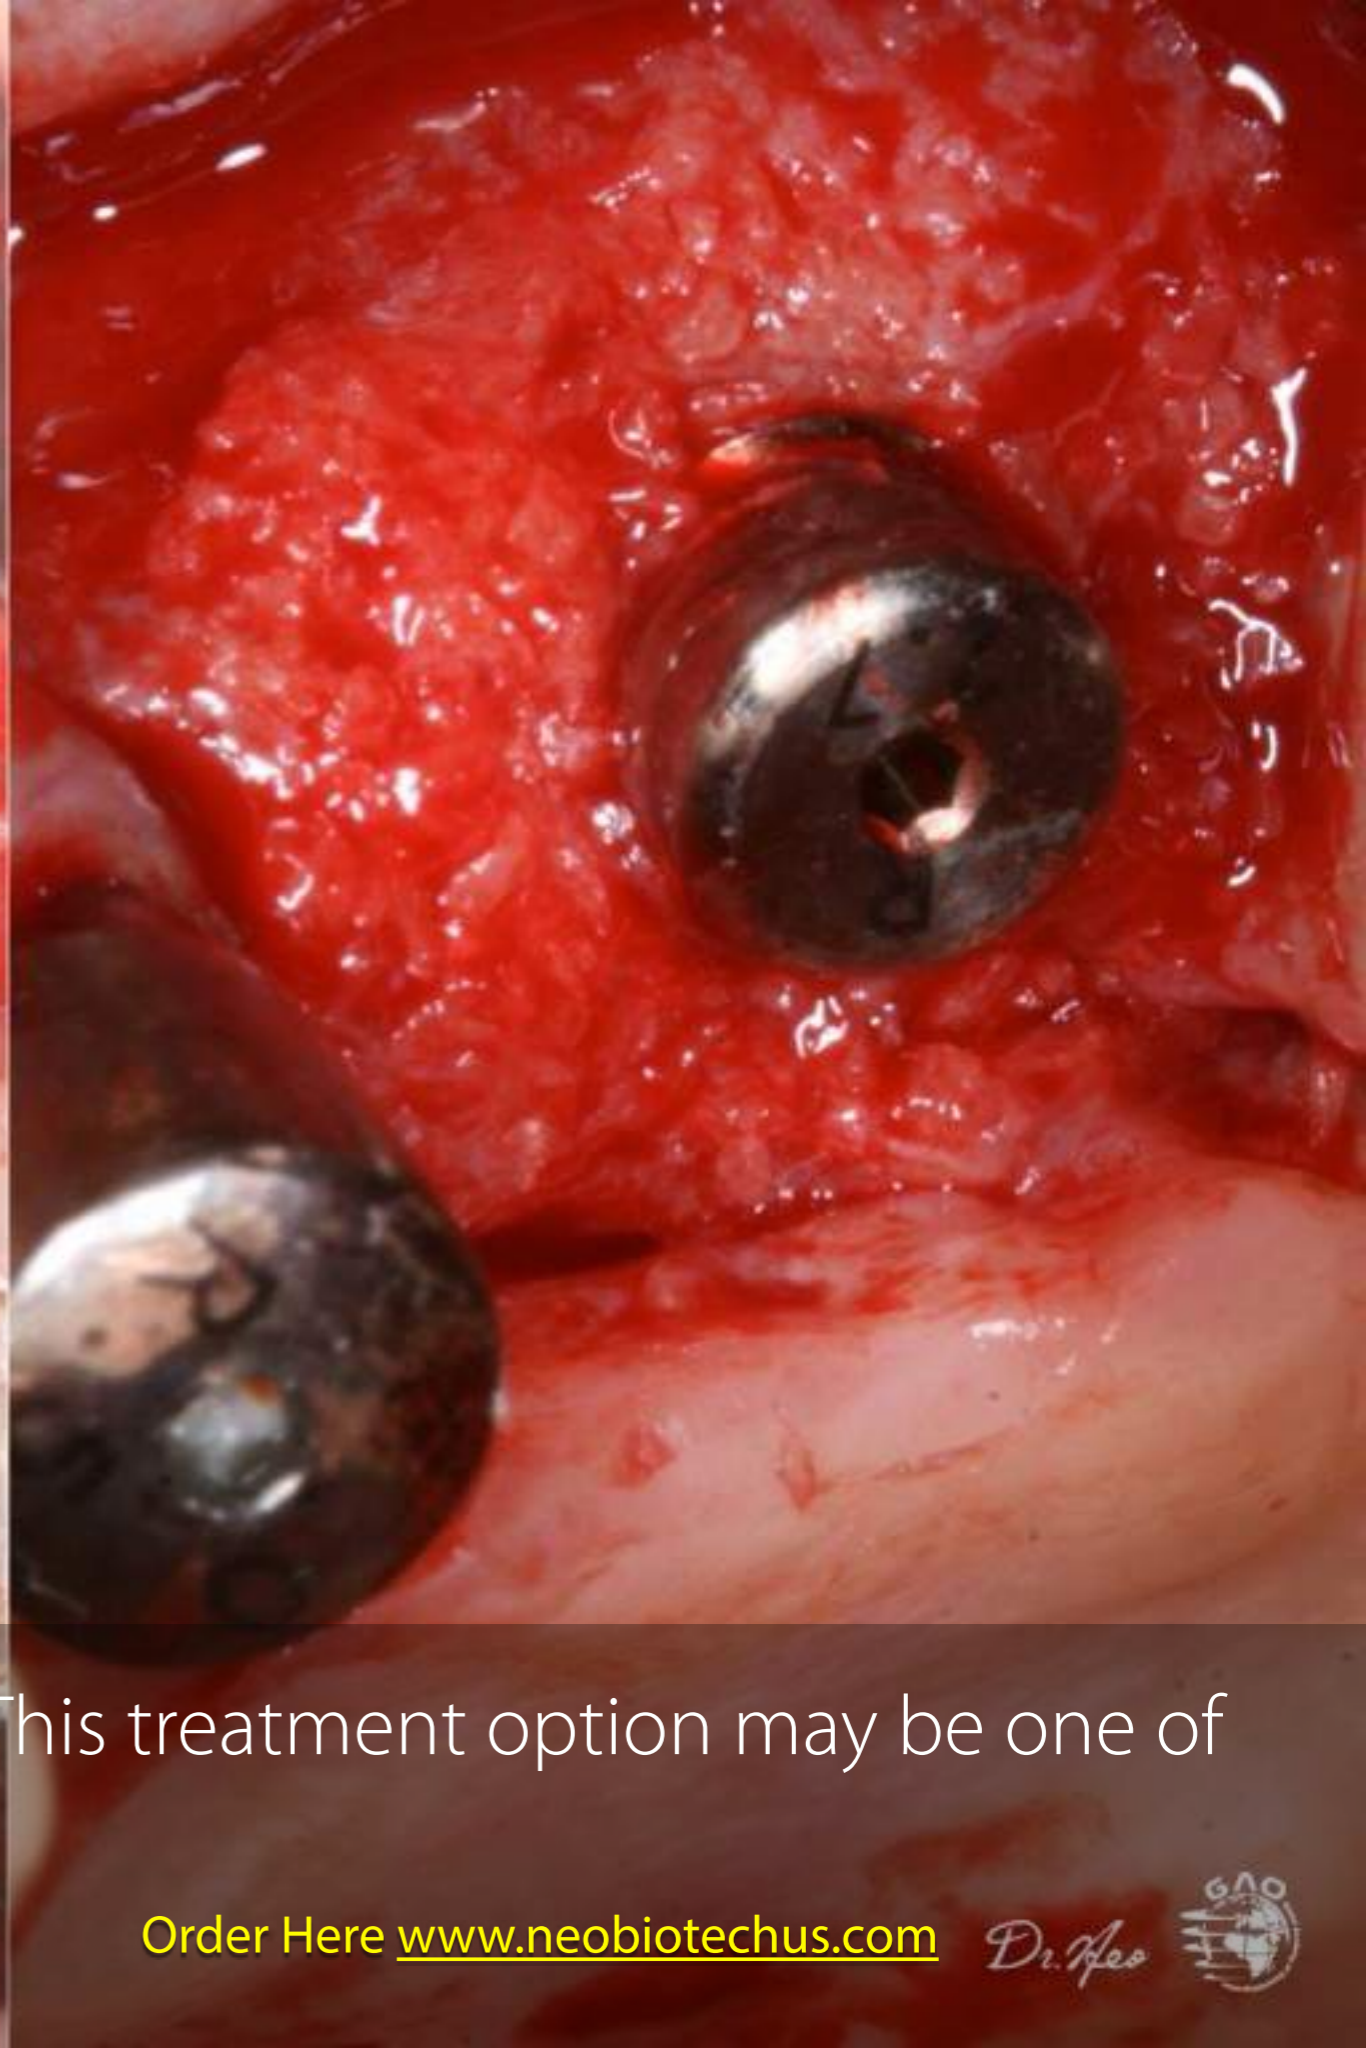
8 months follow-up.

Again, before and after the treatment. This treatment option may be one of the options for treating periimplantitis.
